TB GEN018

TECHNICAL BULLETIN

Date : 28 January 2017
Product : Passenger Lift Range
Subject : FX Structure – Torque Settings
Pages : 2

Originator : Stannah Lifts Ltd, Anton Mill, Andover, Hants SP10 2NX 01264 339090

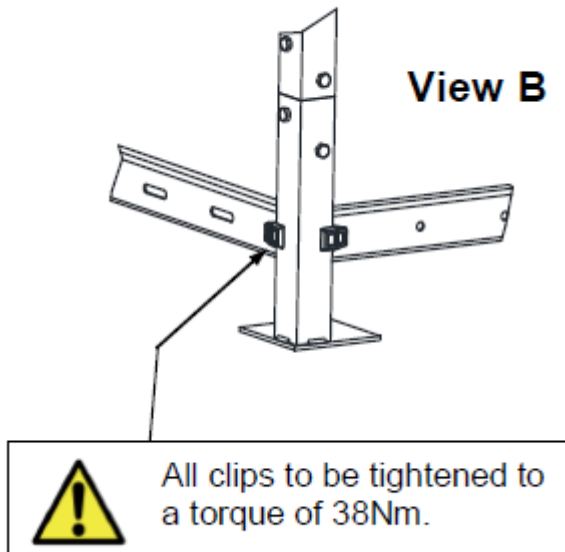
Upon investigation it was found that the clips to tighten the ring section had not been tightened adequately.

Note: Image is an extract from Issue 2 Installation Manual; torque value subject to change when manual is updated.

- When installing FX Structure, please follow the current version of the Installation Manual;
- Please comply with the torque settings provided in the Installation Manual – see extract below:
