TB 103

TECHNICAL BULLETIN

Product : Midilift XL+

Subject : Torque arm fixing assembly

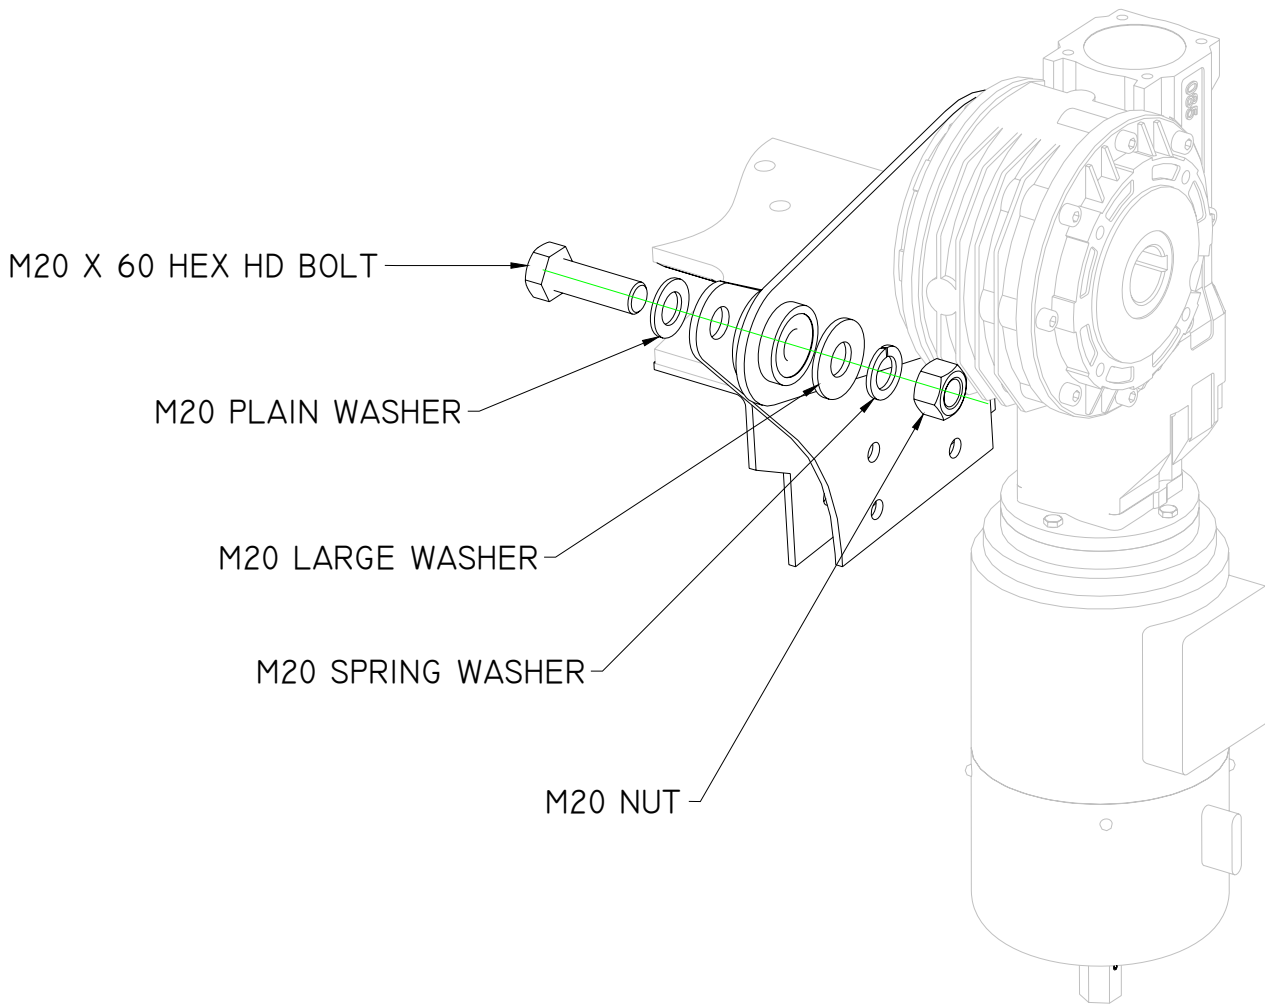
It has been brought to our attention that there is the possibility on the XL+ lift of the rubber insert on the motor torque working its way out of the fixing assembly and allowing the motor to move along the shaft.
This issue was recorded as a near miss on a recent site.
A design change has been implemented to include the use of a larger M20 washer.

The following page illustrates how the fixing arrangement must be assembled to ensure that the motor cannot separate from the torque arm.
If you have any queries relating to this issue please contact the design dept at Stannah Lifts.
