TB 132A

TECHNICAL BULLETIN

Product : Midilift XL+

Subject : Addition of cabin roof stop switch (revision A)

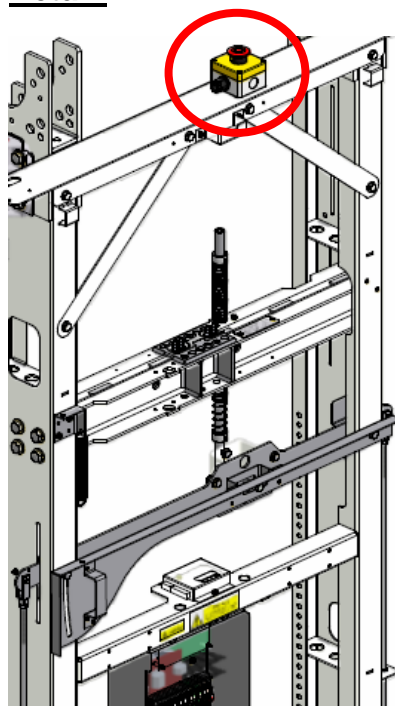
All Midilift XL+ lifts manufactured after 11/06/12 will have a cabin roof stop switch installed as standard.

The stop switch has been integrated into the safety chain and is located between ‘G7D’ and ‘G8’ terminals.

Specific connection details can be found in the wiring manual supplied with the lift.
