TB 135

TECHNICAL BULLETIN

Product : Midilift XL+

Subject : Load weighing device - known issue with setup. Explanation and resolution

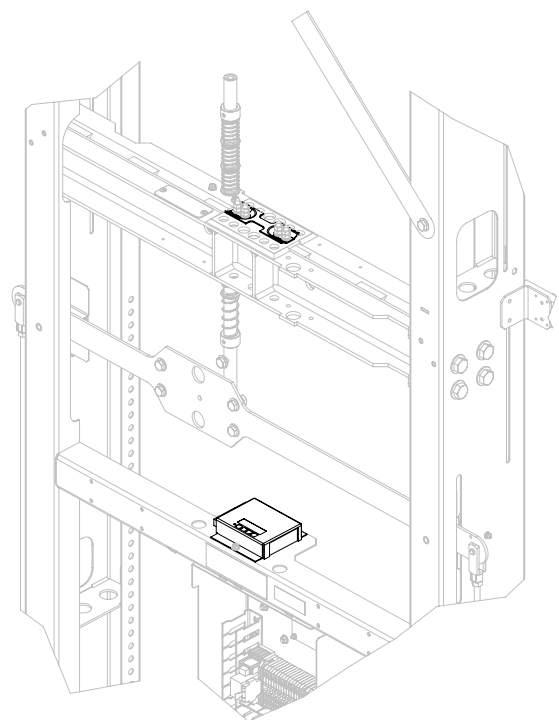
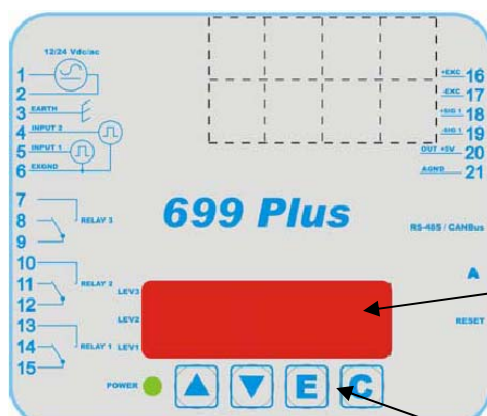
Load Sensor Controller Interface

A Strain Link Load Weighing System has been chosen as load weighing device for the Midilift XL*plus*. Since its introduction there has been numerous reports relating to problems with calibrating the unit. All of these problems occur during the TARE (zeroing) function while in calibration mode.

1. Display shows ER.22 (error 22) while trying to zero (TARE) the unit.
- or
2. After completing the setup and on pressing 'C' to exit calibration mode, the unit does not show 0kg load.

1. If unit is showing ER.22 after the countdown of the TARE function, skip this step and move on to the next calibration steps (HI, FSCA & LEV1). once the calibration is completed (Excluding the TARE function), press C to exit the setup and then lean in to the cabin (without placing any load on the platform) and press C again. **This should zero the unit - display should read 0.**
2. If on completion of the setup (including the TARE function) the unit does not display 0, then lean in to the cabin (without placing any load on the platform) and press C. **This should zero the unit - display should read 0.**
