**TB155**

## **SAFETY BULLETIN**

**Subject :** Incident Report 1088

**Product:** Platform Lifts – Midi Lift SL

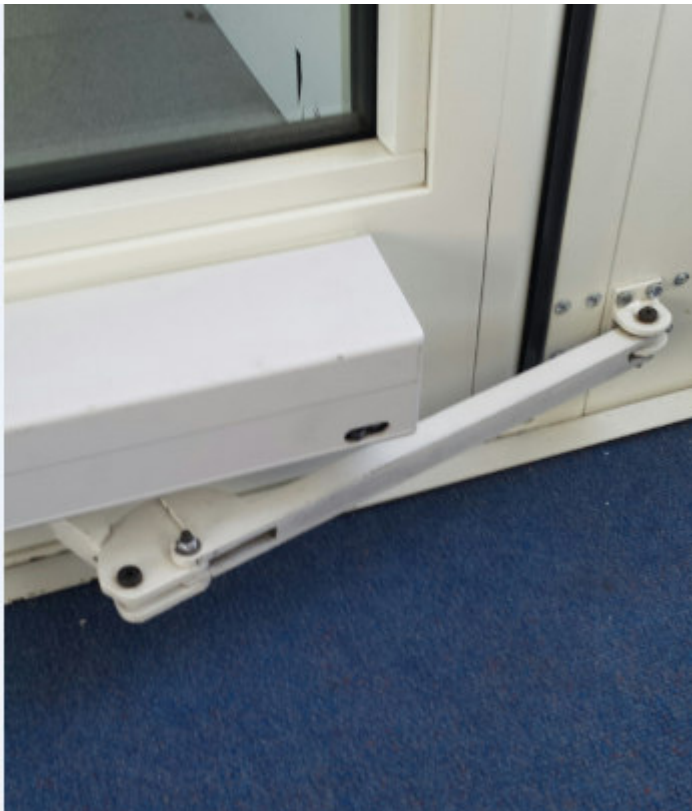
Norwich Service Branch attended site on the 6/3/15 – He noticed, “the lift door operator has a ‘nip’ point on mechanical operation in the open position”. Mark Freeman has spoken to Lifts Ltd (Nick Powell) who advised, “the operator arm is fitted incorrectly. The arm should be fixed to the slam over to the left four fixing holes, which would then remove the nip point being created”.

Door closers to be fitted on site as per installation manual.
