TB156

SAFETY BULLETIN

Subject : Incident Report 2105

Product: Midilift SL

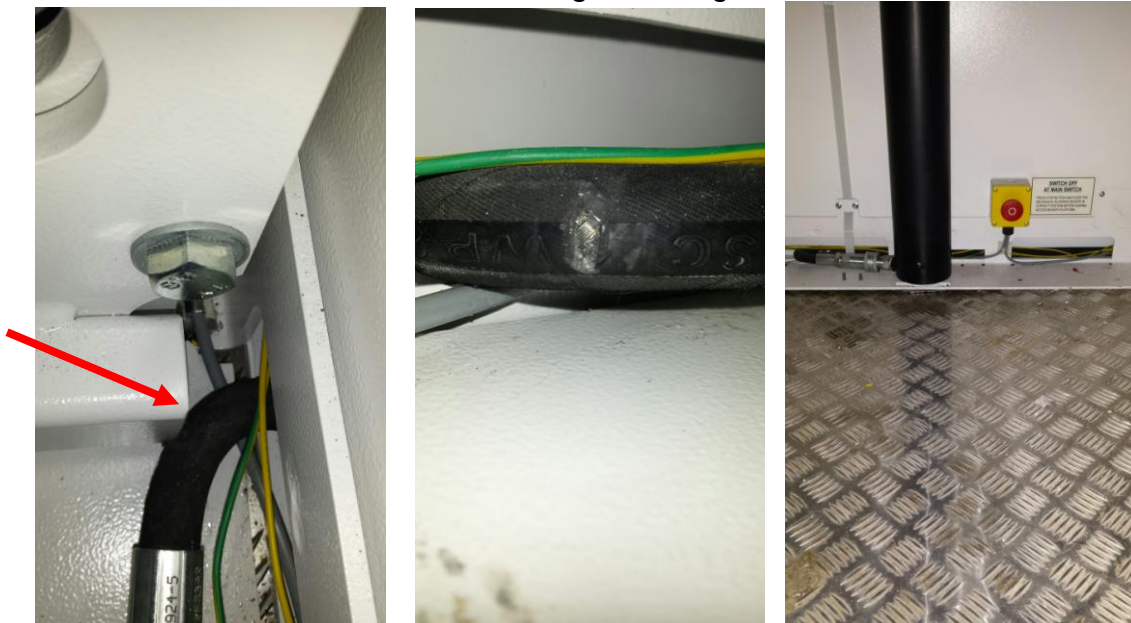
Christchurch service branch engineer attended site and noticed some black rubber near the hydraulic hose. On further instigation, he found that the lift hose had been hit by the lift every time it stopped at the ground floor. The engineer changed the orientation of the hydraulic ram inlet 180 degrees and replaced the hose so that the hose entered the well without a 180 degree bend forcing the pipe work into and onto the platform floor obstruction.

Photos of incorrect installation resulting in damage to the hose

Please ensure that when installing the hydraulic hose that the hose is routed clear of any obstruction when the platform is at its lowest level. 180 degree bends are to be avoided

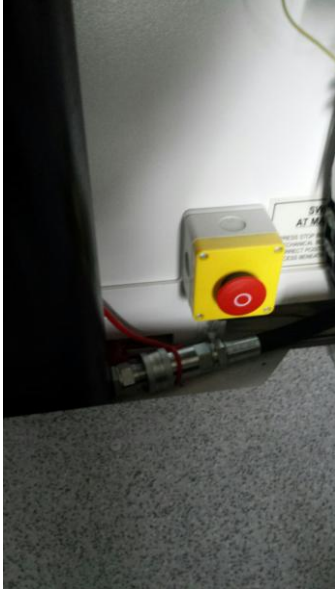
Photo of the rerouted hose
