TB 109

TECHNICAL BULLETIN

Product : Stannah Stairiser SX

Subject : Straightness of rail during installation

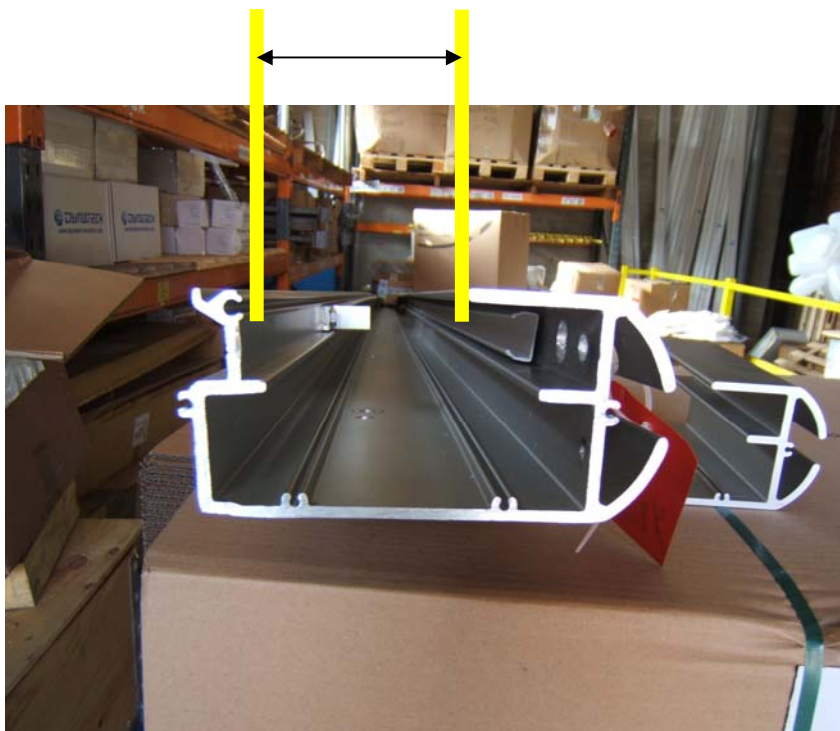
We have recently reported a 'near miss' event on a Stannah Stairiser SX during installation and testing. Whilst testing, the lift disengaged from the 4.5m rail and slid down the staircase approx 300mm until the re-engagement of the gear and activation of the OSG.

The rail was sent back to our factory for investigation where we discovered that it was significantly distorted which had opened the gap between the rail and where the skate would travel. The following picture shows the gap in question. When looking down the rail it could be seen to be distorted over its length.

We are currently unable to determine exactly where and when this bending occurred. This is the first such occurrence reported in 10 years of production and installation.

We have now set up end of line checking in the factory and at the aluminium extrusion supplier to ensure that rails are not in this condition before going to site.

This technical bulletin is to inform installers of the incident and to request that rails must be examined and visually checked for their straightness before and after installation to avoid this occurring again.
