**TB154**

## **SAFETY BULLETIN**

**Subject :** Incident Report 1066

**Product:** Platform Lifts – Lehner Stair riser CR

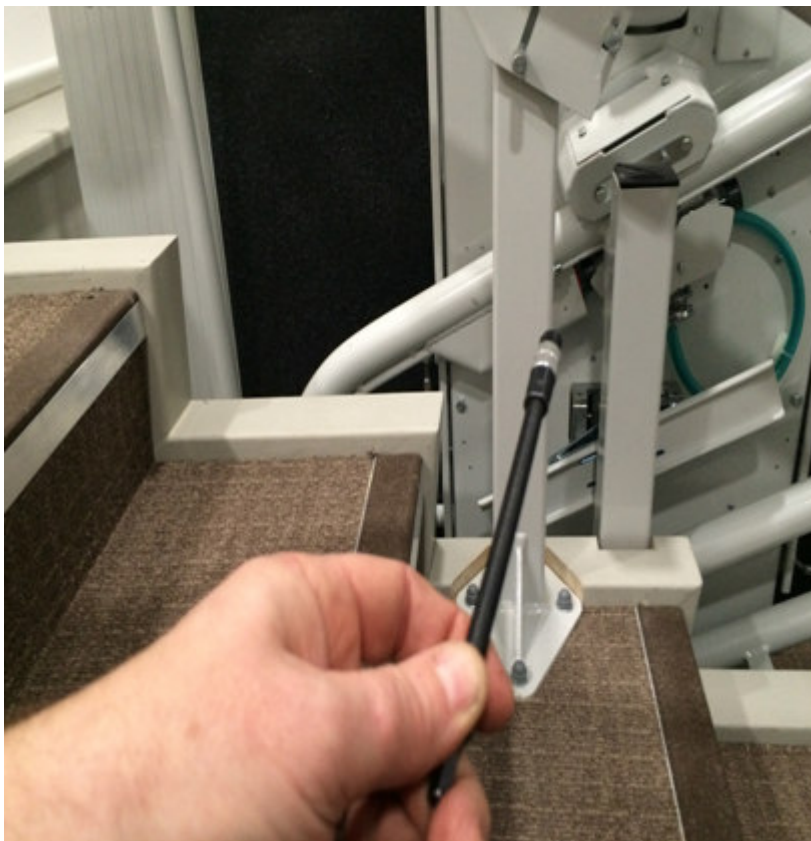
Brackley Service Branch attended on 1/12/14 – “Engineer attended on 1<sup>st</sup> service visit. Found the over travel limit switch had failed. The switch could not be made in the event of over travel failure as it would have made contact the wall and floor before it could ever have made the switch. Incorrectly installed/not tested. Adjustments/corrections made by Engineer”.

The ultimate limit has to be adjusted on site to suit the site conditions by the installer.
