TB – MP0023

TECHNICAL BULLETIN

Product : Xtralift 2.0 (MP)

Subject : **False Ceiling Stoppers**

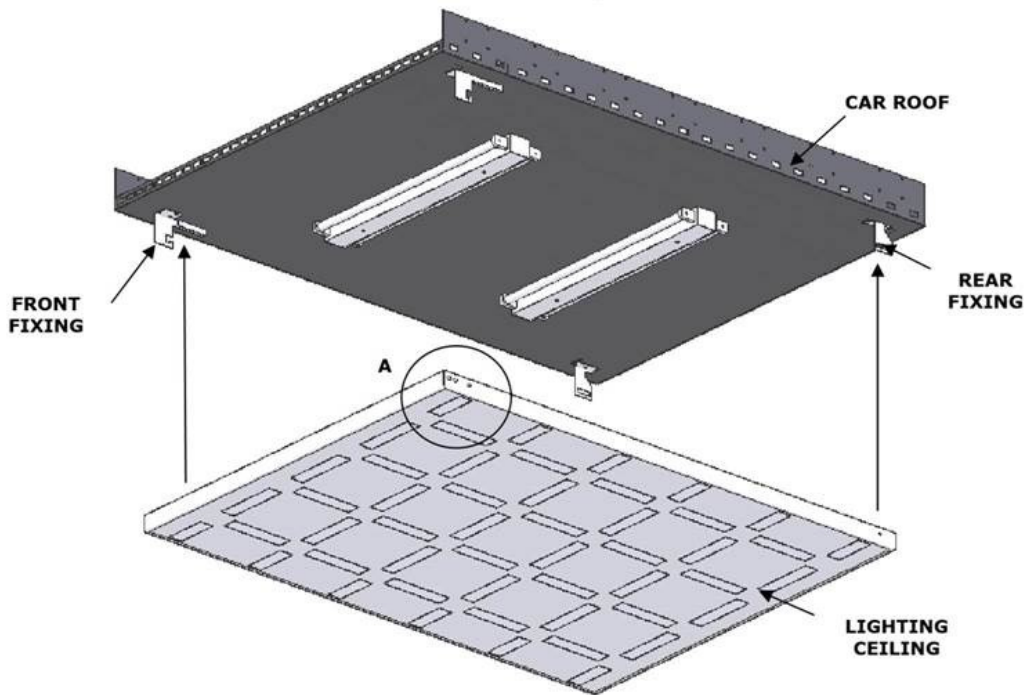
16.5. OPENING OF FOLDING LIGHTING CEILING, HEIGHT 80 mm

All, we have had 3 incidents over a three-year period with false ceiling falling with MP lifts. We don't believe they fall independently. Something such as furniture being moved in the lift car pushes the false ceiling back and it slips out of the fixing brackets (see diagram below). The rubber stoppers would prevent this movement.

We believe this is happening – installers and/or service engineers are removing these stoppers when cleaning the ceiling or changing lights; and not replacing them.

STEP 1: REMOVE THE SAFETY STOPPER

STEP 2: SMOOTHLY PUSH THE GRATING UPWARDS TO THE END

STEP 3: PUSH THE GRATING TOWARDS THE REAR PART

1. The MP false ceiling must have the stoppers in place;
2. SLL Contract Managers & Testers to check when on site;
3. If removed at any time during installation – they must be replaced;
4. If removed at any time during service – they must be replaced;
5. SLL will issue will issue packs of these ‘stoppers’ to Contract Managers & Testers;

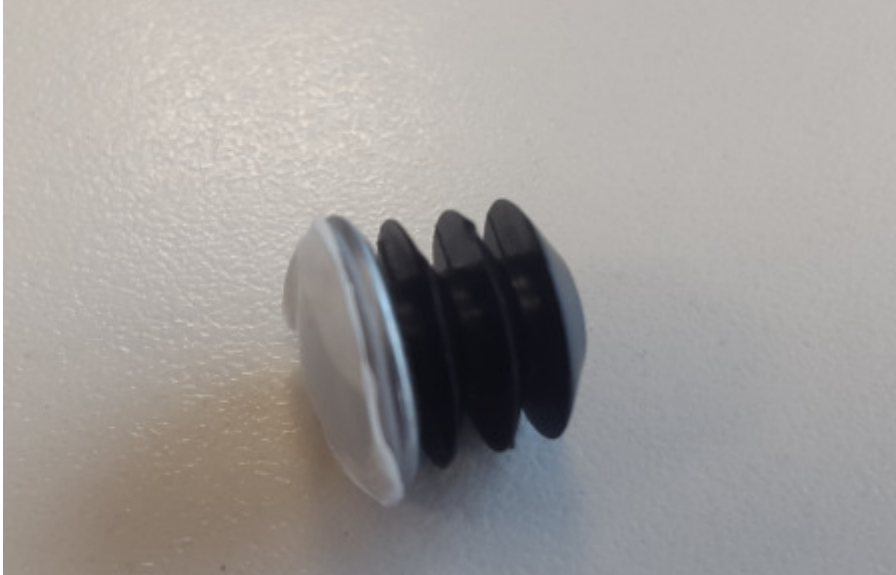
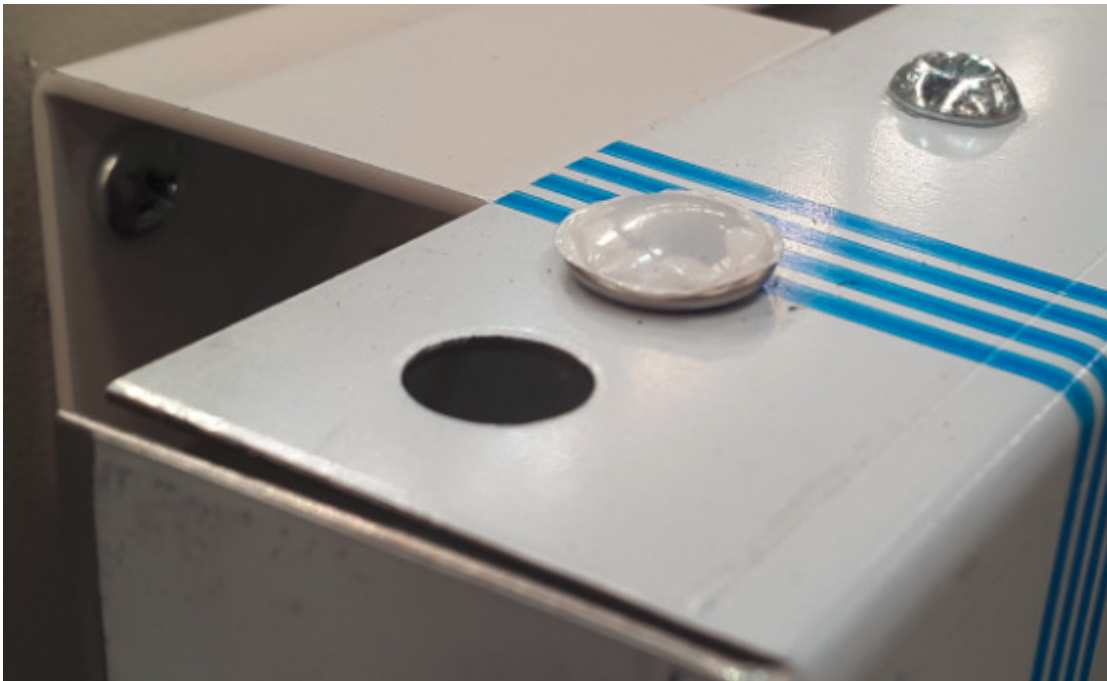
Pictures of rubber stoppers:

MP have advised that their lifts are provide from the factory with black rubber 'stoppers'. See pictures attached.
