Stannah

TB-MP016

TECHNICAL BULLETIN

For the At	Graham Mears, Larry Power, Peter Amura, Contract ention of : Managers, Service Branch Managers, Testers, Margaret Pitman	
From:	Pete Canning – Product Support Manager (Passenger Lifts)	
Date :	29February 2016	
Product :	MP	
Subject :	VVVF Transformer Failure Version 2	
Pages :	3

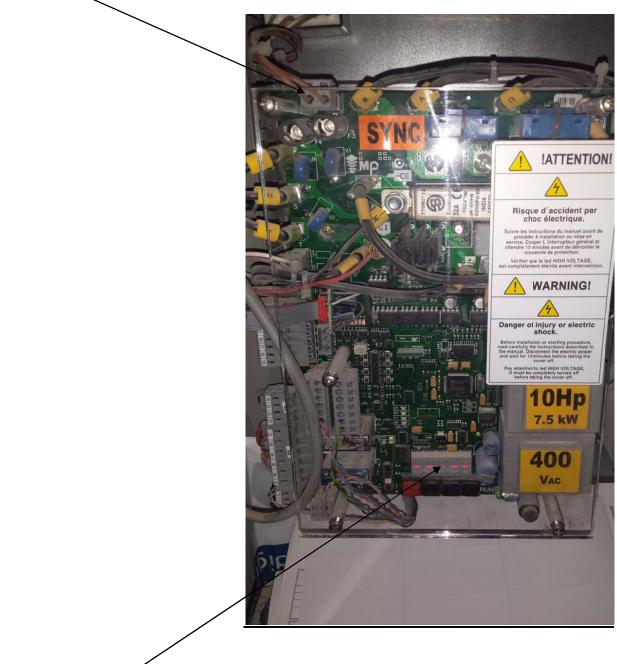
XC12 Plug will have 415 volts on it but the display will be blank.

No Display shown here (The picture shows the normal display.)
