TB-MP018

TECHNICAL BULLETIN

Subject : **Inverter Issues - Version 3**

Subject: 3VFMACDSP Power supply issues

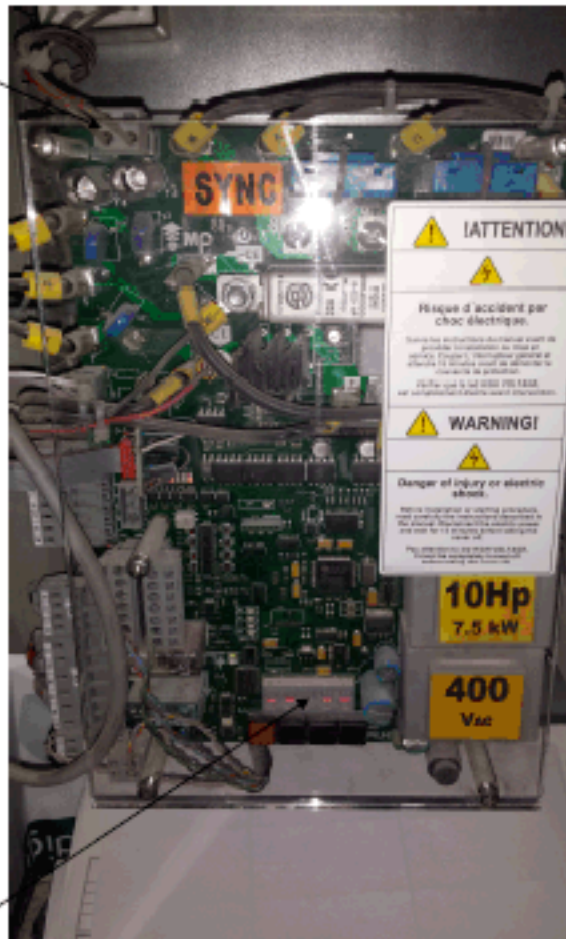
How to identify a faulty drive (Caused by Transformer failure.)

XC12 Plug will have 415 volts on it but the display will be blank.

No Display shown here (The picture shows the normal display.)

MP Will offer Stannah a warrantee of 5 years on all DSP inverters produced in and between 2013 – 2015 and will therefor issue free of charge a new or retrofitted unit for any units with power failure due to transformer or Transguard issue (Sympton ->no display)
