**TB-MP019**

## **TECHNICAL BULLETIN**

**Product :** MP

**Subject :** **MP Car DBG**

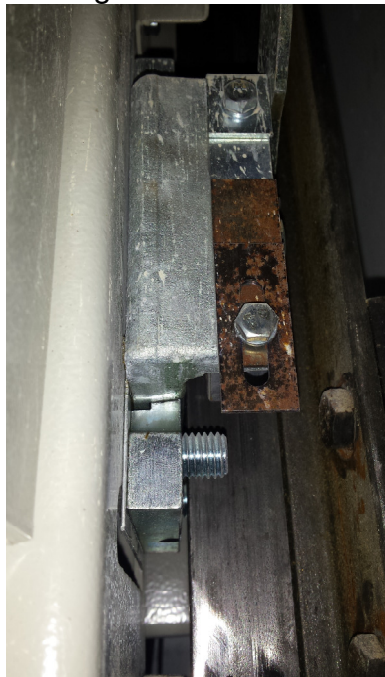
It appears that when the MP Car DBG has been set to the DBG on the General Arrangement drawings, the tolerance between the guide face and the safety gear block is 0.6mm.

This small tolerance causes the safety gear block to rub in certain cases and provides extra noise during travel.

Please set all Car DBG's 2mm greater than what has been drawn on the General Arrangement drawings.

The tolerance should be taken up using the packers supplied by MP with the lift.
