# SAFETY INFORMATION PCI 63000224

**Subject:** Instruction PCI N°63000224 sent by TKEMS

**PRODUCT CORRECTION INSTRUCTION  
OVERSPEED GOVERNOR SG-200 & SG-300 ELECTRIC CONTROL FAULTY**

No.: PCI 63000224 Rev. 01

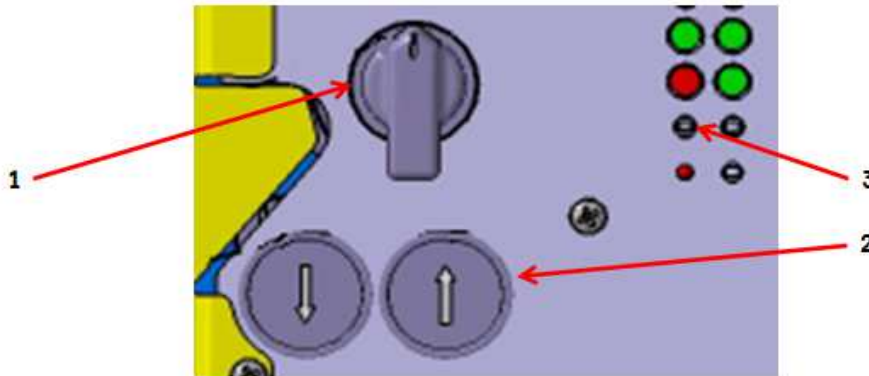
→ **The tester should not sound** (the contact should be open).

If the tester sounds, please refer to chapter 2.2 ADJUSTMENT OF THE OVER SPEED GOVERNOR CONTACT (see instruction PCI 63000224).  
If the governor contact is located on wall side with no access for adjustment, please dismantle it according to the maintenance manual 3017422.

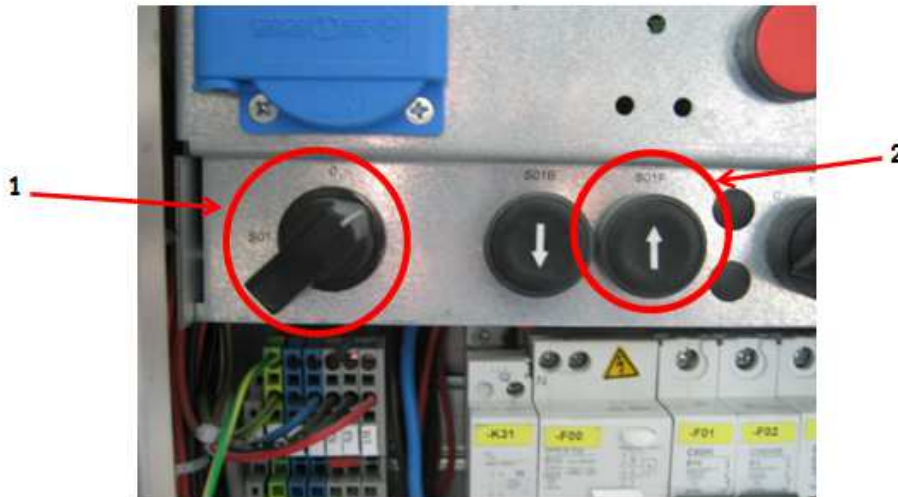
→ **The tester should not sound** (the contact should be open).

If the tester sounds, please refer to chapter 2.2 ADJUSTMENT OF THE OVER SPEED GOVERNOR CONTACT (see instruction PCI 63000224).  
If the governor contact is located on wall side with no access for adjustment, please dismantle it according to the maintenance manual 3017422.

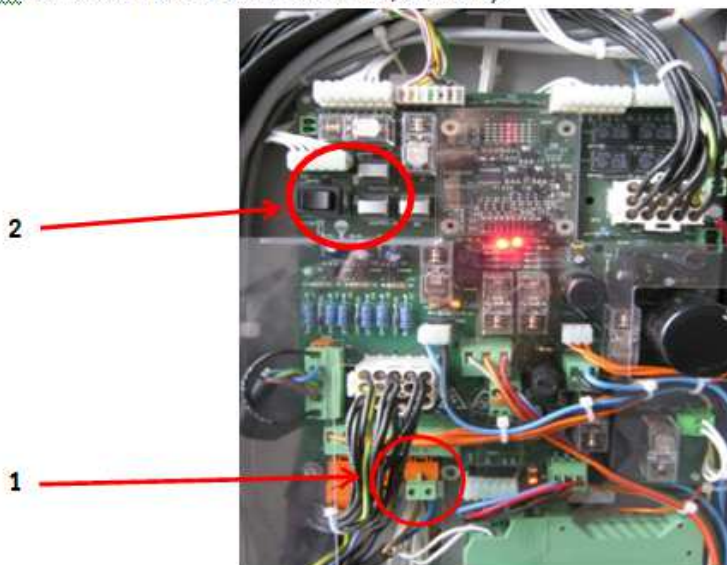
→ **The tester should not sound** (the contact should be open).

If the tester sounds, please refer to chapter 2.2 ADJUSTMENT OF THE OVER SPEED GOVERNOR CONTACT (see instruction PCI 63000224).  
If the governor contact is located on wall side with no access for adjustment, please dismantle it according to the maintenance manual 791834000.
