SAFETY INFORMATION PCI 63000224

Subject: Instruction PCI N°63000224 sent by TKEMS

PRODUCT CORRECTION INSTRUCTION
OVERSPEED GOVERNOR SG-200 & SG-300 ELECTRIC CONTROL FAULTY

No.: PCI 63000224 Rev. 01
 Page: 1
 DATE Rev. 00: 21/07/2014
 DATE Rev. 01:17/09/2014

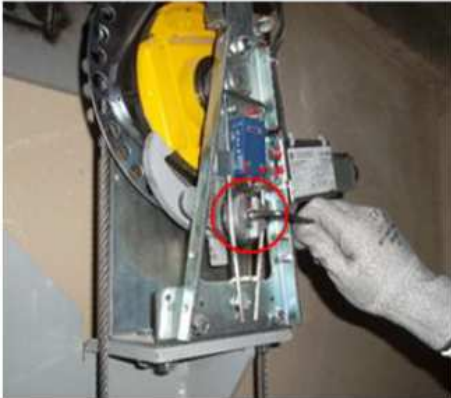
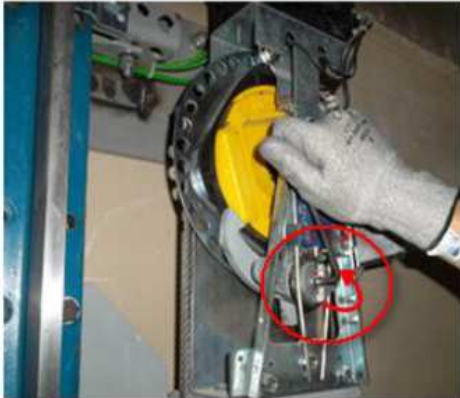
Due to this customer complaint the failure was analyzed with the conclusion that some version of the Overspeed Governor SG-200 and SG-300, that includes the electrical switch XCM 2110S38 and XCM2910 S38; under two joint circumstances the electrical switch could fail.

- Misalignment between the central plane of the electrical switch and the central line of the cam actuator.
- The distance between the actuator of the electrical switch and the cam actuator exceeds 2.5 mm

2.2.1.1. Loosen half turn the screw of the cam actuator indicated in the picture

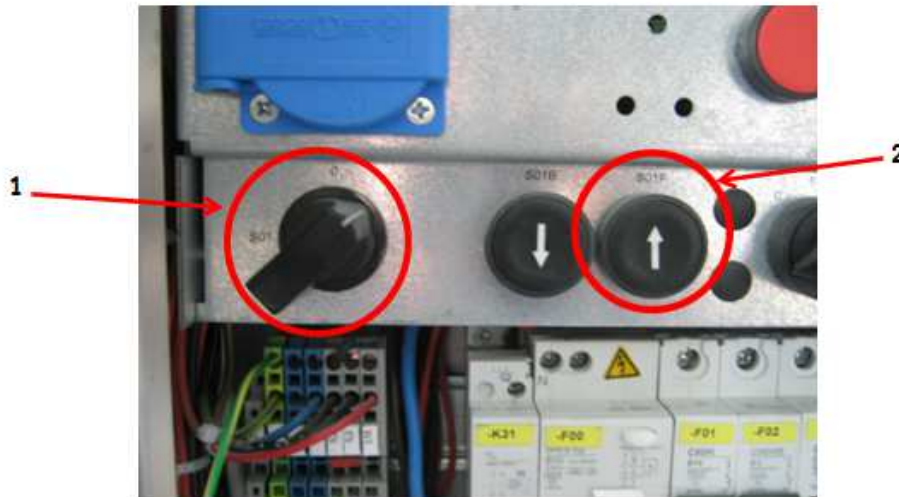
→ **The tester should not sound** (the contact should be open).

If the tester sounds, please refer to chapter 2.2 ADJUSTMENT OF THE OVER SPEED GOVERNOR CONTACT (see instruction PCI 63000224).
If the governor contact is located on wall side with no access for adjustment, please dismantle it according to the maintenance manual 3017422.
