**TB 113A**

## TECHNICAL BULLETIN

**Product :** Maxilift Hydraulic

**Subject :** Introduction of New Safety Gear Activation Plate

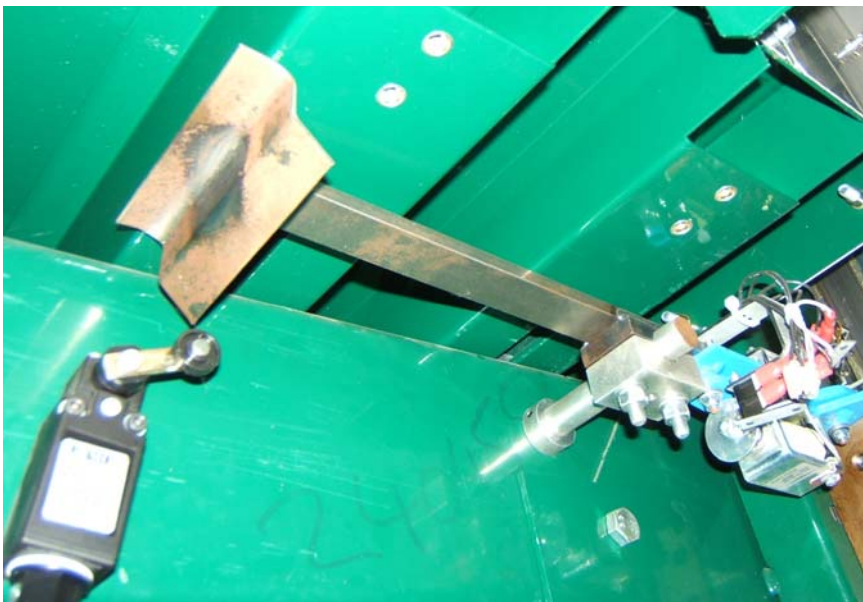
The previous safety gear activation arm had come under some scrutiny on site from installers and testers. More times than not the previous arm had to be bent and manipulated to get into the correct position to work.

The old arm assembly and arm switch. Located on the outer part under the floor. This is on both sides but only one is used due to what hand the lift is.

To deal with this problem a new activation plate was designed. This new plate, along with a new switch, aim to be easier to set up and require no tampering to work.

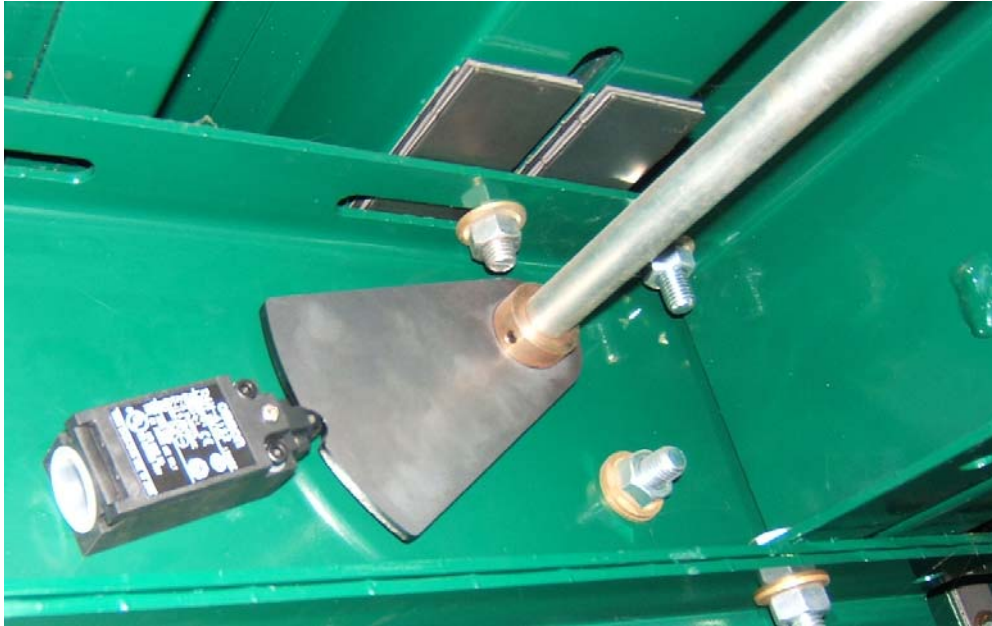
Here is how the new safety gear plate looks fitted on the inner part under the floor.

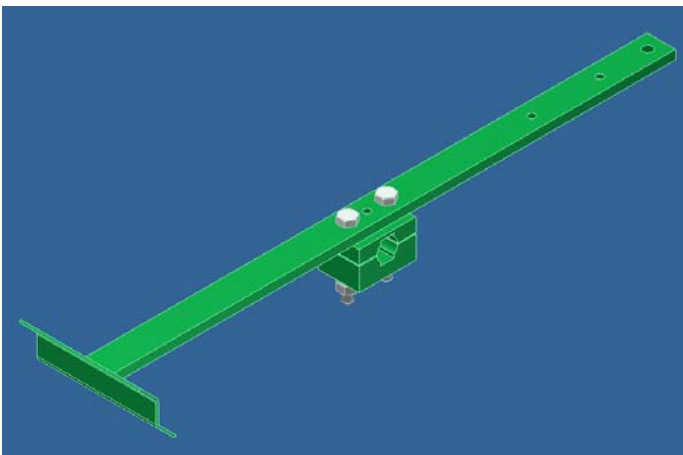
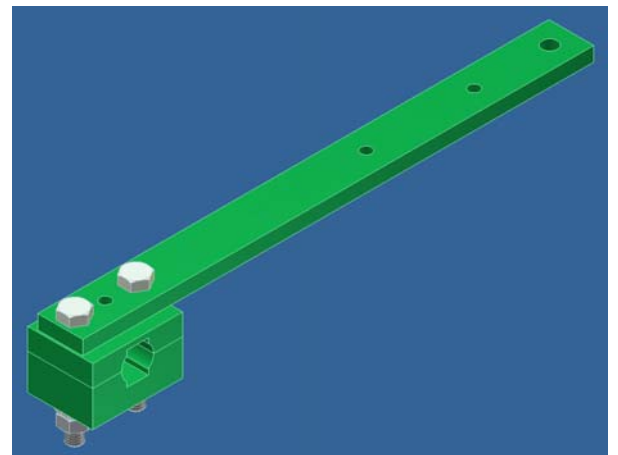
The activation plate acts in the same manor as the arm. When the safety shaft rotates, it moves the plate with it pushing down the 'plunger' on the switch activating it.

The construction of the plate is a simple cut out from sheet metal with a collar inserted and welded onto it.

With the position of the plate, installers and testers have more area of movement around the lift as the old arm will now be removed from the assembly due to it being obsolete.

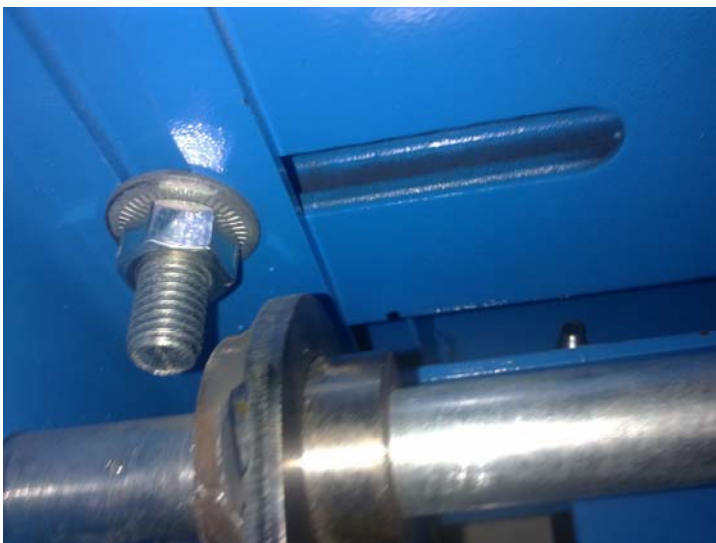
An issue has been highlighted with the actuation plate design; if the safety gear actuation plate is fitted **after** the car floor is assembled and fitted to the sling assembly then the safety gear actuation plate **will not** pass the halfen fixing holding the floor in place shown below.

To overcome this issue the safety gear **must be** fitted before the car floor is assembled, if this can not be achieved then the floor will have to be loosened and raised so that the actuation plate can pass the halfen bolt and be correctly fitted as above.
