TB 129

TECHNICAL BULLETIN

Product : Maxilift Hydraulic models

Subject : Emergency manual lowering valve (VSMA)

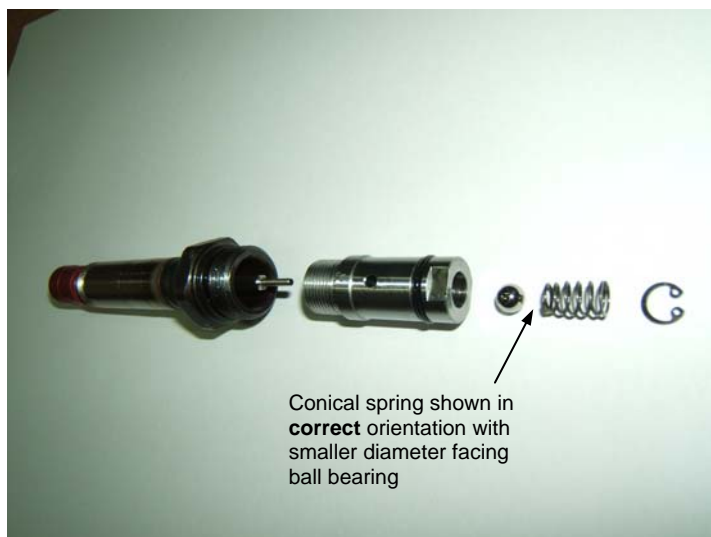
The issue relates to the emergency manual lowering valve on the NGV and NGV-A3 electronic valve block supplied by GMV. There have been 4 separate instances where the conical spring, which acts on the ball bearing to close the valve, has been assembled the wrong way round. This can result in the ball bearing becoming lodged inside the spring after using the manual lowering button to relieve the high pressure when undertaking a 200% pressure test or pressure relief test. As a consequence, the valve will be jammed in the open position and the lift will continue to descend at slow speed when the button is released.

Exploded assembly of emergency manual lowering valve (VSMA)

If the above fault does occur during testing of the lift then the manual lowering valve must be disassembled and the spring reoriented to its correct position or the complete valve replaced.
