TECHNICAL BULLETIN

Product : Maxilift traction – 8 Person models

Subject : Cooling fan on drive machine

Originator : Stannah Lifts Ltd, Anton Mill, Andover, Hants SP10 2NX 01264 339090

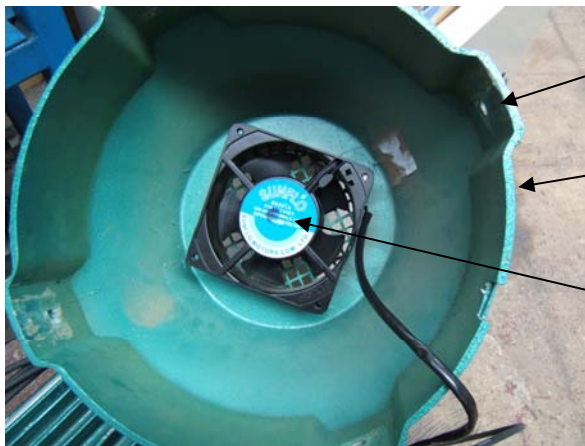
It has been brought to our attention that the cooling fan has been incorrectly assembled, by our supplier, on some Permagsa gearless machines. The cooling fan is designed to suck air from the top of the lift well and blow the air over the motor. We have been informed that on some units the fan has been orientated the wrong way around. This results in the cooling fan being less effective which can significantly reduce the duty cycle of the lift, causing the motor to overheat and consequently taking the lift out of service.

Cowl secured to motor body
via 4 x M5 Hex head screws

Cowl removed from motor to give
access to cooling fan after isolating
240V power supply

Cooling fan shown in **correct**
orientation with notice facing
inwards towards the motor

It is recommended that the correct orientation of the fan is checked, particularly on any installations where overheating of the motor has been an issue.

- Checking the direction of airflow at the motor cowl. If the air is being exhausted from the motor then the fan is incorrectly assembled
- Isolating the fan 240V power supply and removing the motor cowl to expose the cooling fan as shown below.
