TB 133

TECHNICAL BULLETIN

Product : Maxilift Hydraulic models – Direct acting

Subject : Fixings on direct acting sling extension

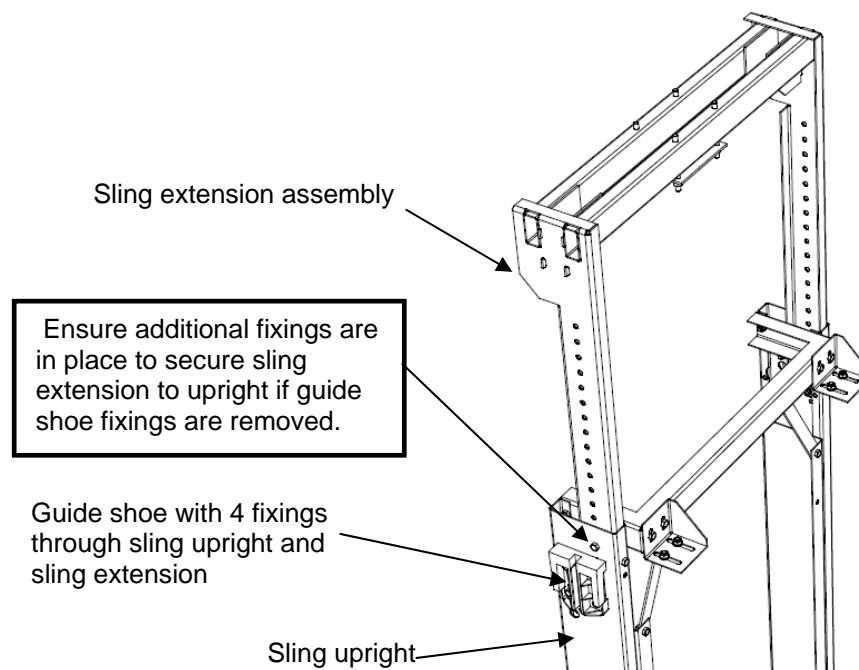
The issue relates to direct acting hydraulic Maxilift models manufactured between May 2001 and August 2006. During this time guide shoes were fitted at the top of the sling and the guide shoe fixings also secured the sling extension assembly to the sling uprights. Removal of the guide shoe fixings can therefore result in the lift becoming detached, causing the lift car to drop if additional fixings have not been used in the additional holes provided, as intended.

It is recommended that site personnel are extra vigilant when removing fixings from direct acting slings. If a guide shoe needs replacing it is important to check that additional fixings have been utilized to secure the sling extension assembly to the sling uprights. Failure to do this can result in the lift becoming detached causing the lift car to drop.

It is therefore also recommended that this work is carried out with the lift positioned on the buffers or pit prop.
