**TB 137**

**Product :** Hydraulic Maxilift models with NGV A3 valve block (GMV)

**Subject :** False NGV F51 faults logged by Nexus

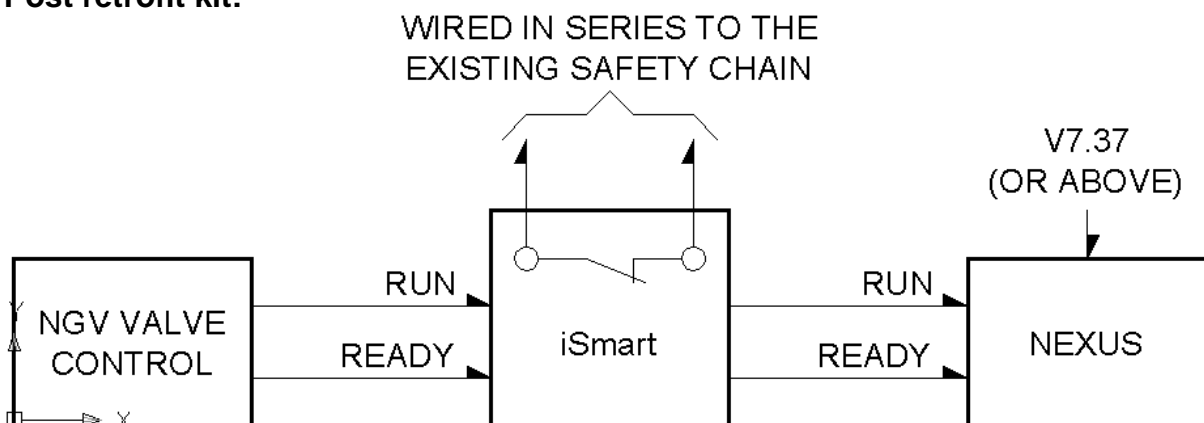
However, in some unexplained cases, the Nexus controller has been found to log false NGV F51 faults (i.e. fault is registered by Nexus but not by the NGV control board).

This NGV F51 fault is a latch fault and will force the lift out of service requiring either a controller or power reset to clear.

The NGV iSmart retrofit kit is required to prevent further faults being logged. This kit can be obtained direct from our spares department (part number = 1009274).

The iSmart device will assume NGV A3 monitoring responsibilities whilst providing Nexus with relevant RUN and READY signals.

If a genuine NGV A3 valve fault occurs, the iSmart will isolate the safety chain preventing further lift movement.
