TB 143

TECHNICAL BULLETIN

Product : Maxilift Hydraulic Lifts fitted with GEV electronic valve

Subject : GEV PCB failures

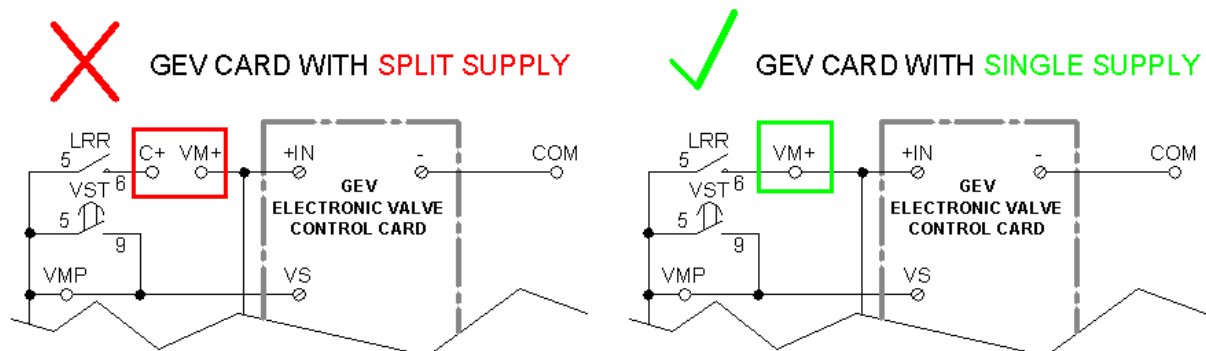
GEV electronic valve control PCB's, used on GEV hydraulic drives, are susceptible to failure if wired with a split (C+ and VM+) supply connection.

All contracts produced and tested between March 2010 and October 2010 are wired with this split supply.

It is not possible to identify and target all contracts which have been wired with a **SPLIT SUPPLY**. Therefore, the following action is required to all GEV hydraulic Maxilift's during the next scheduled service visit.

The power supply to the GEV card must be re-connected directly to the VM+ terminal only (see '**SINGLE SUPPLY**' diagram below). In addition to this wiring modification, a dedicated DC power unit is also required to ensure sufficient VM+ supply is maintained.

1. Inspect supply connection to GEV control PCB.
2. No action is required if already wired with a **SINGLE SUPPLY** (see diagram on page 1).
3. If a **SPLIT SUPPLY** is identified (see diagram on page 1), a **dedicated DC power supply kit is required**. This kit contains relevant modification instructions and will ensure the GEV PCB is powered by a single VM+ supply only.
4. Reconnecting to a single VM+ supply must be completed at the same time that the **dedicated DC power supply kit** is installed.

If a **SPLIT SUPPLY** (see diagram on page 1) is identified, then a **dedicated DC power supply kit** must be installed to prevent future failure of GEV PCB.
