TB 90A

Product : Maxilift Traction Passenger Lifts

Subject : Tensioning of Overspeed Governor Rope.

Originator : Stannah Lifts Ltd, Anton Mill, Andover, Hants SP10 2NX 01264 339090

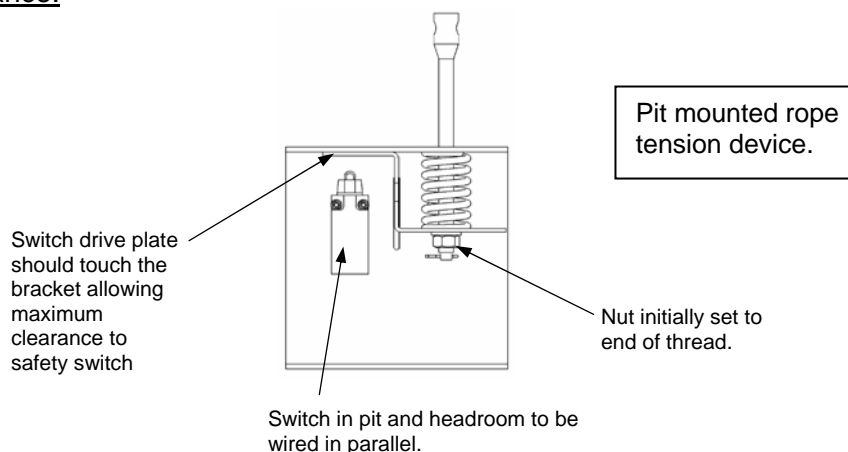
This technical bulletin has been re-issued (with rev status 'A') to emphasize the importance of correct installation and maintenance of the overspeed governor rope on the Maxilift traction lift model. Correct tensioning ensures that the two rope safety switches, which are provided to detect rope breakage or a slack rope condition, are set to their *maximum clearance*. Insufficient tensioning of the rope could lead to the switch drive plates in the upper and lower tension device, activating the safety switches after a period of time, thus breaking the electrical safety circuit and putting the lift out of service.

- 1) During installation the rope should be pre-tensioned to compress the springs such that the plate touches the bracket. However, care should also be taken not to over-tension the rope since this could reduce the life of the rope and the governor.
- 2) Prior to installing and pre-tensioning the rope, the nuts on both tension devices should be set to the end of the thread as shown. This facilitates subsequent tensioning of the rope to accommodate rope stretch which is most prevalent during early use of the lift.
- 3) The rope safety switches mounted on the bracket in the pit and in the headroom are designed to be wired in parallel as shown on wiring diagram 9410/4 of the electrical wiring manual.
- 4) It is recommended that the switch clearances are checked during commissioning of the lift and subsequently at each service interval and if necessary adjusted for maximum clearance.
