TB 96

STANNAH LIFTS LTD

TECHNICAL BULLETIN

INSTALLATION			MAINTENANCE ISSUE
For the Attention of :		Service Engineers, Installers, Trade Customers, Testers, Training Dept, H & S Manager etc	
Date :	19-03-2010		
Product :	MRLi Lifts using GEV valve assemblies and Pawl Device.		
Subject :	Modification to power supply wiring.		
Pages :			
Originator :	Stannah Lifts Ltd, Anton Mill, Andover, Hants SP10 2NX 01264 339090

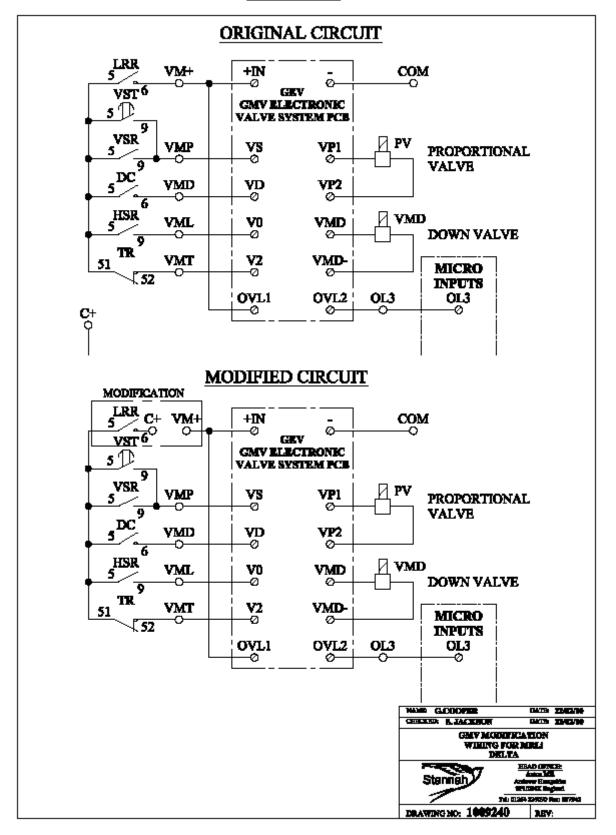
DELTA

As a result of introducing the Pawl device and Blain Valve to MRLi lifts it has been found that the power required to energise the VMD hydraulic valve is sometimes insufficient. This, in the majority if instances, becomes apparent during testing before handover, but may also present itself whilst the lift is in service. The symptoms are that the lift does not lower with full load in the car.

The modification is to change the feed to the valves from VM+ to C+ as shown overleaf.
