Stannah Lifts Technical Bulletin

Issue No: M13 Date: 20/08/01

LIFT TYPE:- Homelift - Eye bolt orientation in cabin frame assembly.

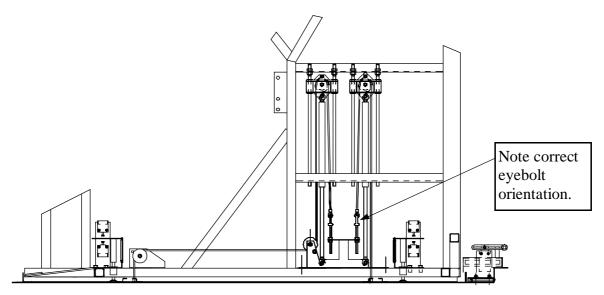
It has come to our intention that in some instances the gas struts supporting the Homelift underpan have failed causing the lift to break down.

It is important that during installarion, the eyebolts are fixed in the correct orientation to prevent interference with the gas struts when the lift is approaching the upper floor level.

We recommend that the orientation of eye bolts is checked on subsequent service visits.

Please to be advised that a label will be attached to all future Homelifts to illustrate the correct positioning of the eyebolts as shown below.
