**LIFT TYPE:- STANNAH HOMELIFT**

**Re:- Adjustment of Stannah Homelift Concertina Panels.**

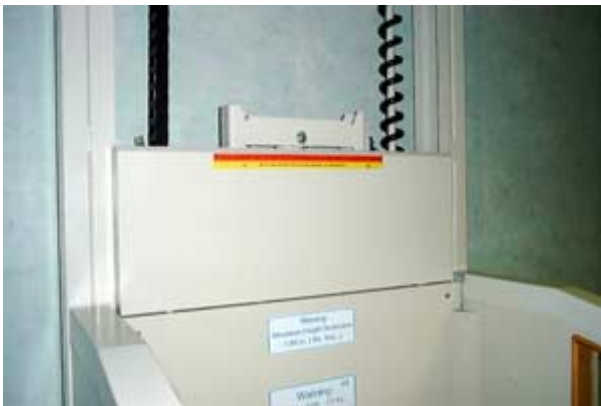
*Fig a. Label shown positioned on the bottom concertina panel.*

It has come to our notice that some of the Stannah Homelifts in the field have not been maintained with the correct adjustment/overlap of the rear concertina panels.

A safety label has been made available and we would recommend that this be fitted as shown to all units in the field to ensure that the overlap does not exceed the minimum dimension shown.

Should any Homelifts be found with insufficient overlap, the panels should be adjusted so that equal overlap is achieved.

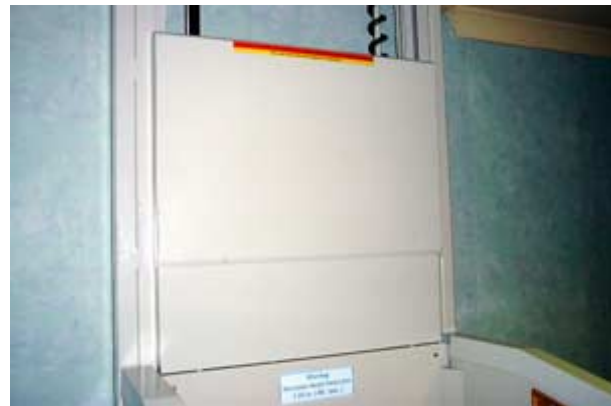
*Fig b. Label shown positioned on the middle concertina panel.*
