Stannah Lifts Technical Bulletin

Issue No: M1

LIFT TYPE:- HOMELIFT

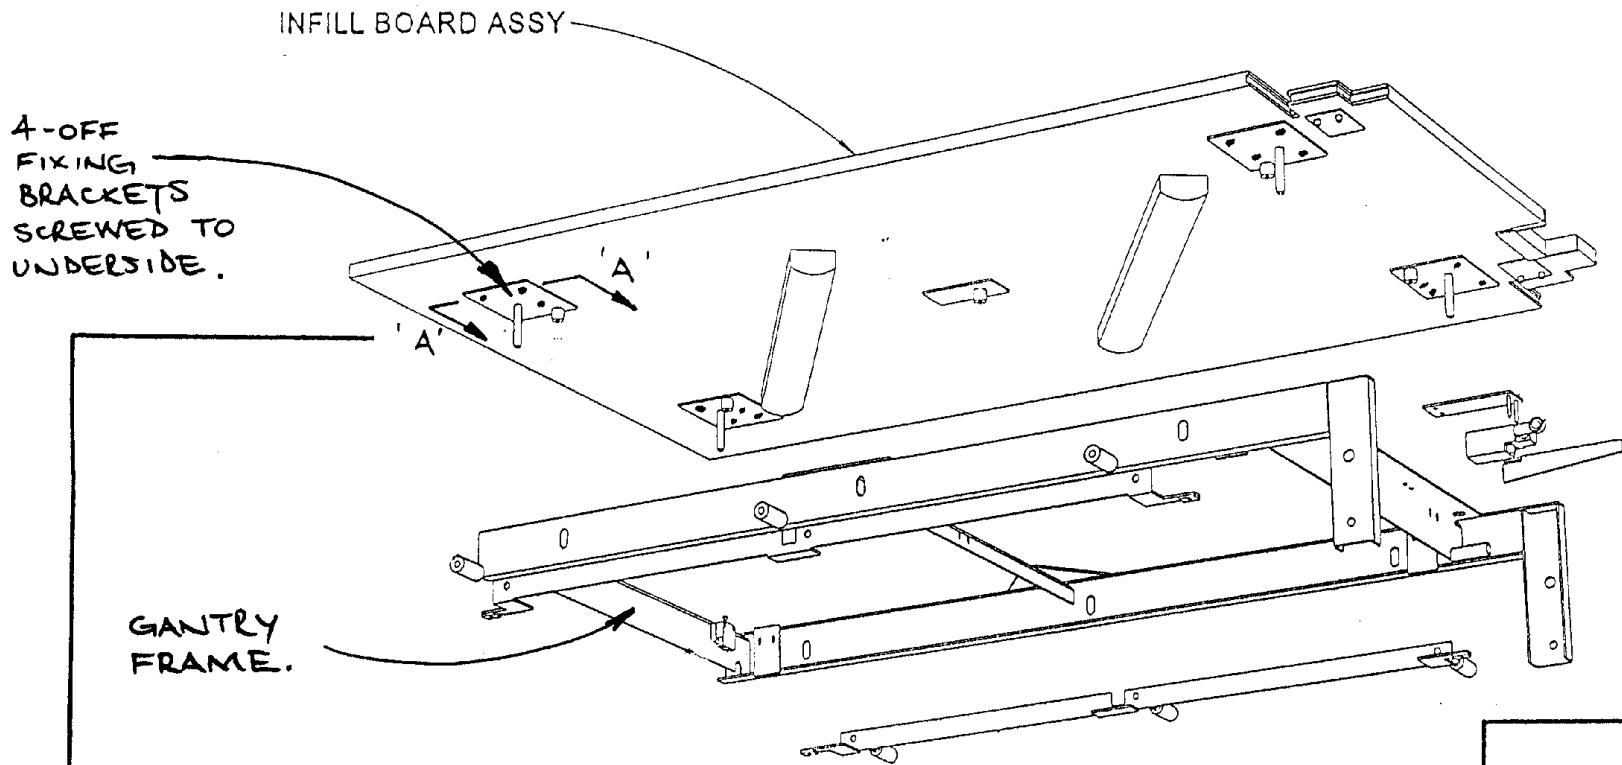
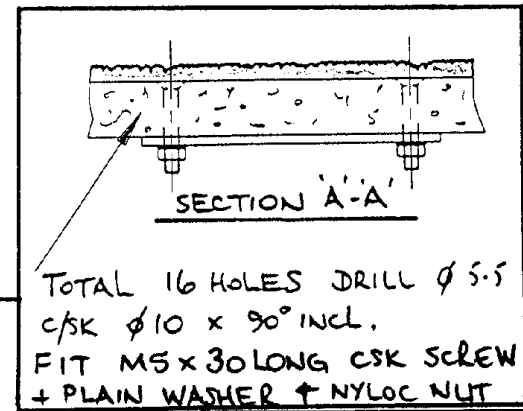
ORG TITLE: GANTRY COMPONENTS (ASSEMBLY)		CHANGE NOTE No:	REV.

The Homelift has an infill panel, which plugs the inter-floor aperture when the cabin is at the lower floor. This infill board has four square brackets screwed to its underside for mounting onto the metal frame. On units manufactured prior to 29.11.96 these brackets were fixed using self tapping screws. It has been reported that on some installations these screws have worked loose. Although this should not create a hazard to the user it may affect the performance of the lift by activating the sensitivity switches.

A preferred method of fixing was introduced on units manufactured after 29.11.96. This is detailed on the attached drawing no. 05300-M1.

It is recommended that on any future site visits to Homelifts manufactured prior to this date that these fixings are checked. If they are found to be loose then the self tapping screws should be replaced with the M5 countersunk screws as detailed on the drawing.
