**Stannah Lifts Technical Bulletin - Safety**

**Issue No: M4**

**LIFT TYPE:- STANNAH HOMELIFT (SHL)**

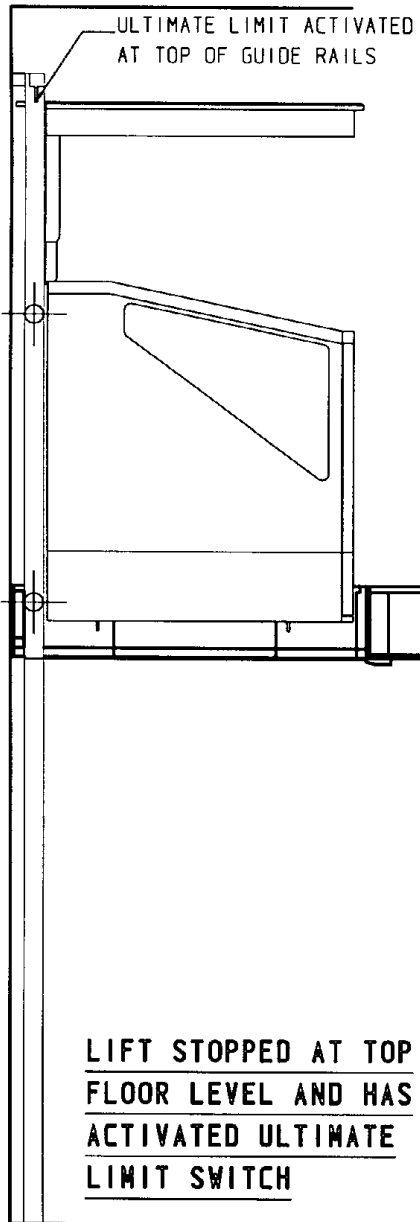
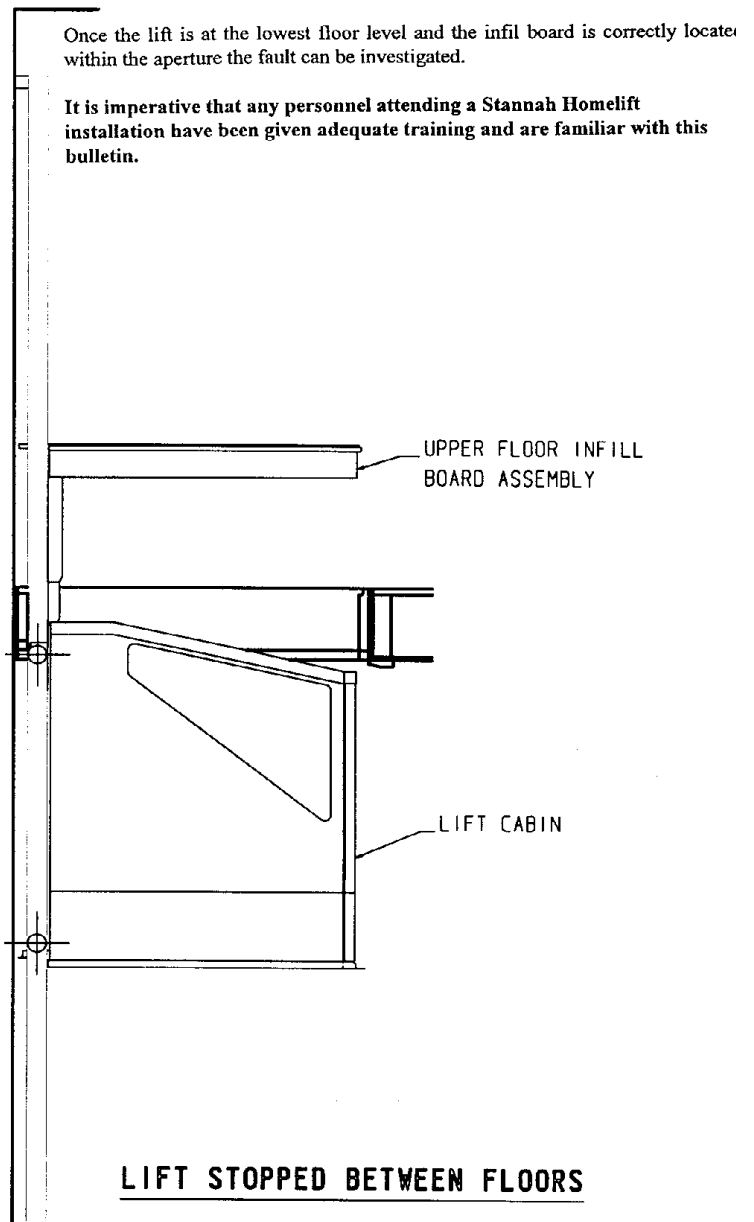
CHANGE NOTE No: H 1285	DATE: 30.9.98
DRAWN: C.S.	REV.
DRAWING NUMBER: HD 3023

Site personnel should exercise extreme caution if a Stannah Homelift is found to be stopped between floors or has activated the ultimate limit switch as shown on the attached drawing, HD 3023.

The above procedure is aimed at eliminating a possible hazard due to the infill board assembly dropping in the unlikely event that it is not correctly supported by the lift cabin.

We strongly recommend that the lift is **manually** lowered to the bottom floor level, in accordance with the emergency lowering procedures, prior to investigating any fault or attempting to operate the lift. It is particularly important that the aperture infill board assembly and concertina covers at the rear of the lift are not touched until the lift has been lowered to the bottom floor level.

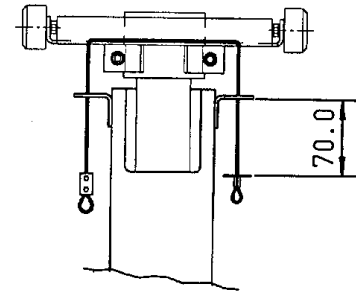
<b>Stannah Lifts</b> HEAD OFFICE Anton Mill Anton Mill Rd Andover Hampshire SP10 2NX England Tel:01264 339090 Fax:01264 337942			CHANGE NOTE No:		
			DRAWN: Dave J DATE: 24/8/98		
DRAWING NUMBER: <b>HD3024</b>				REV.

It has been reported that 2 incidents have occurred on Stannah Homelift installations where the cord supporting either the middle concertina cover at the rear of the lift or the cord supporting the hydraulic ram sliding cover has failed causing the cover to drop.

- 1) The wrong specification of cord being used.
- 2) The cord having been subjected to excessive wear or abrasion.
- 3) Failure of the knotted rope terminations.

- This retrofit will replace the existing nylon cord to the outer ram cover with new 2mm wire rope and more secure terminations. A physical stop will also be fitted at the base of the hydraulic ram to protect the hydraulic coupling from any shearing hazard.

REMOVE EXISTING NYLON BRAIDED CORD  
THIS WILL BE LOCATED AT THE TOP  
OF THE RAM COVER

SOLDERLESS NIPPLE WITH KNUCKLE SCREWS  
FOR ADJUSTMENT. TRIM EXCESS ROPE  
ENSURING WIRE ROPE IS LOOPED BACK  
INTO NIPPLE.

FEED WIRE ROPE THROUGH EXISTING HOLES  
IN RAM HEAD ASSY AND OUTER RAM COVER  
ENSURE WIRE ROPE DOES NOT INTERFERE  
WITH MOVEMENT OF RAM

REMOVE EXISTING SCREWS IN BASE OF FIXED RAM COVER  
FIT NEW 'U' SHAPED BRACKET WITH No. 6 x 5/8"  
SCREWS SUPPLIED
