**TB KLN018**

**For the Attention of :** SLL Testers, Service Engineers, Training Dept.  
**From:** Tony Knapp – Product Support Engineer  
**Date:** 08 April 2019  
**Product:** Kleemann  
**Subject :** **LiSA 20 Controller Error 75**  
**Pages :** 1 of 4

| <b>PRODUCT BULLETIN</b> | | Kleemann Ref. No: P.BUL.03.03.19<br>Date: 27/03/2019 | |
| <b>Bulletin Title: Error 75 on LISA20 controller (EN81.20)</b> | | | |

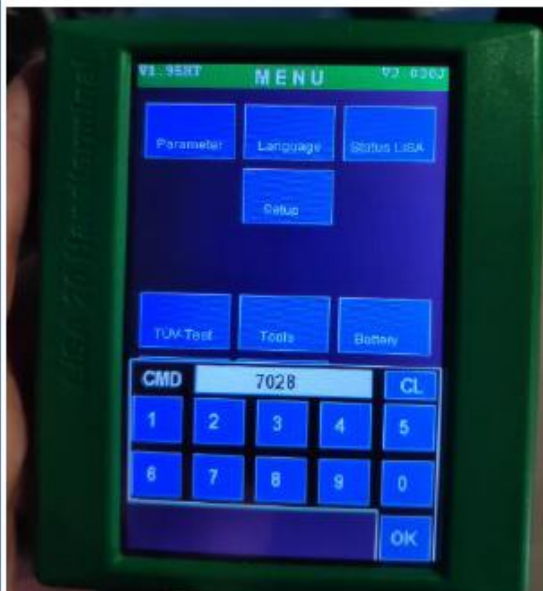
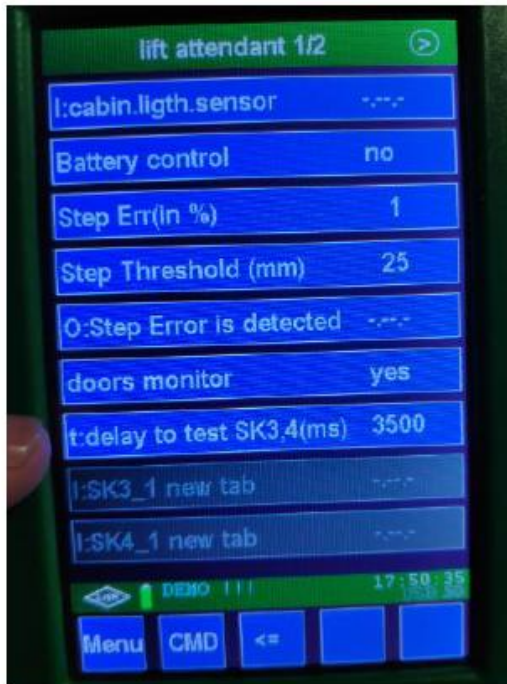
| <p>This bulletin has to do with the error 75 that appears in LISA20 that could be down to timing value of the door check. Of course if the value is already by the factory at the desired level of 3500, then you should try to address the fault in different aspects following the bellow capture of fault explanation from LISA20 manual.</p> <p>To check and alter this value type in command menu 7028 and OK (please see capture bellow) and then change the value of &lt;t:delay to test SK3/4 (ms)&gt; to the value of 3500<br/>Please remember to Save the change when you exit to main page.</p> <p>You should expect all recent projects dispatched after May 2018 to have this parameter update by the factory.</p> | | | |

Capture from LISA20 manual with Error explanation

If Error 75 is logged, check parameter setting as per bulletin
