TB KLN020

TECHNICAL BULLETIN

Product: Kleemann Flexy, aka Stannah Maxilift 2.0

Subject : **UPS Plug Wiring**

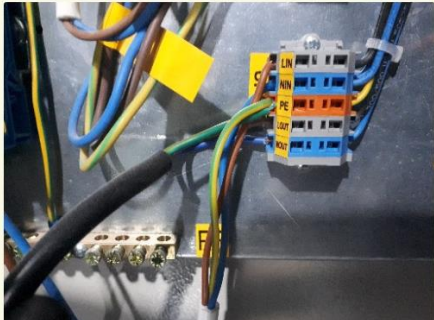
He was working on a Maxilift 2.0 when he noticed the outgoing plug wiring was wired into the input, this could have caused damage to the equipment or if the output plug was unplugged, then the possibility of electric shock.

| Incident Details: | Kleemann UPS was pre wiring was wired up incorrectly by the OEM, the ups output was wired into the supply input voltage of 240v. (Which is a European 2 pin plug) and if was unplugged could cause an electric shock if it came into contact. The UPS input was wired to the output. Which at the very least would cause product damage. |

| Action Taken: | rewired the input and output as in the electrical drawings. |

- When the control panel is first delivered, **before** powering up you must check the **white** UPS output lead is connected correctly.
- The correct terminal are: **Lout for the brown (Live) cable and Nout for the blue (Natural)**
- If unsure you must always consult the wiring diagram and/or call a Stannah Testers for advice
