# Stannah Lifts Technical Bulletin

**Issue No: M15**

## LIFT TYPE:- Midlift PX - Limit ramp.

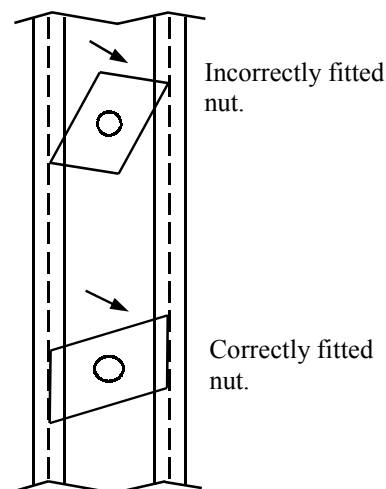
The limit ramp is fixed to a halfen channel located on the platform lift structure and is held in place by two halfen screws and nuts. It has been brought to our attention that if the nuts are incorrectly installed (see diagram below) they may exert insufficient grip to hold the ramp in position, potentially allowing the ramp to slide down the assembly thus giving a false floor level reading, whereupon it may be possible to open a landing door.

During normal service please check that the nuts have been assembled correctly, to do this the ramp will have to be removed. (For identification of component see attached photos). Note: some ramps may be made of steel others may be plastic.

The ramp should be re-assembled correctly ensuring it is in the correct position.
