TB 172

## TECHNICAL BULLETIN

**Product :** Midilift Piccolo (2:1 roped models)

**Subject :** Stump post packers

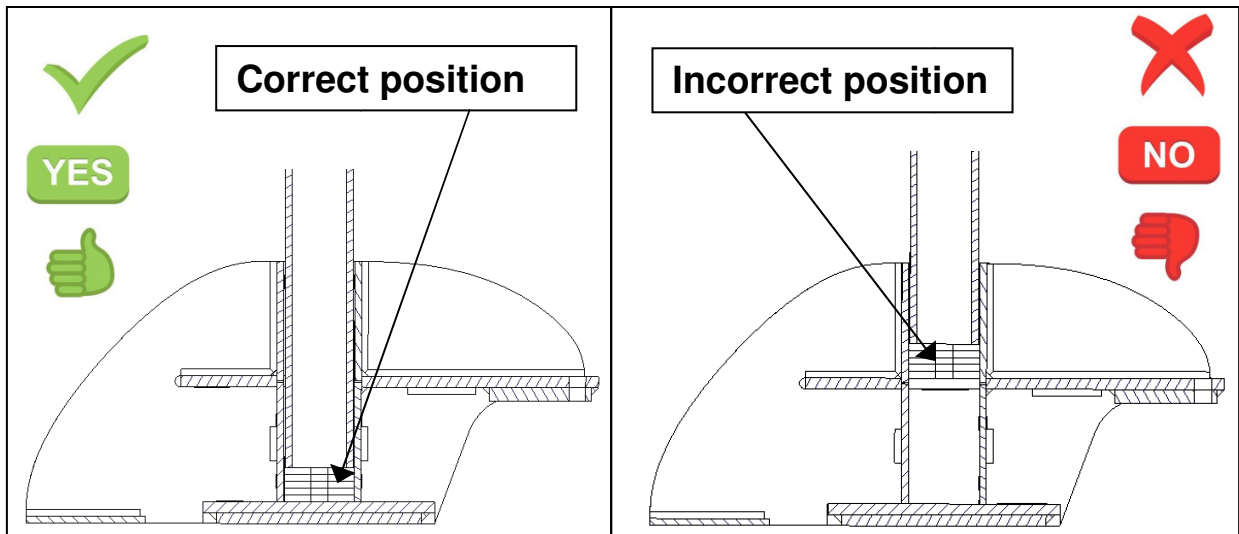
A recent installation has highlighted that it is possible for the packers to be installed incorrectly, whereby the packers are resting on the upper plate rather than the lower plate. This results in the stump post being inadequately supported at an elevated position.

**Installation Engineers** – packers must be installed correctly, as per the extract from the installation guide shown below. This includes any lifts that are part installed but yet to be commissioned and handed over.

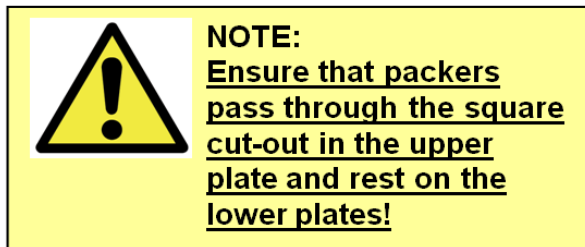
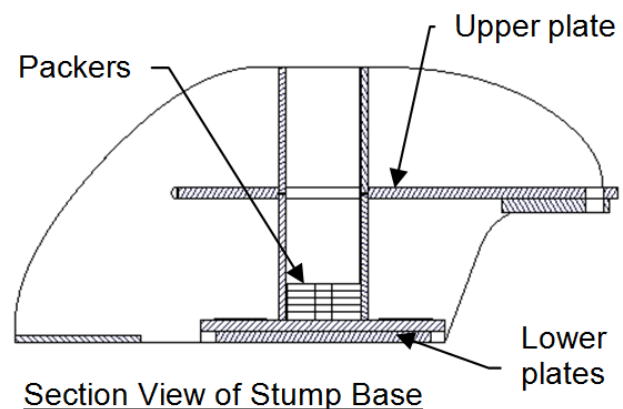
During installation, it is sometimes necessary to install packers below the stump post. These packers should be located on the **lower** plate of the stump base, with the stump post sitting on top of the packers.

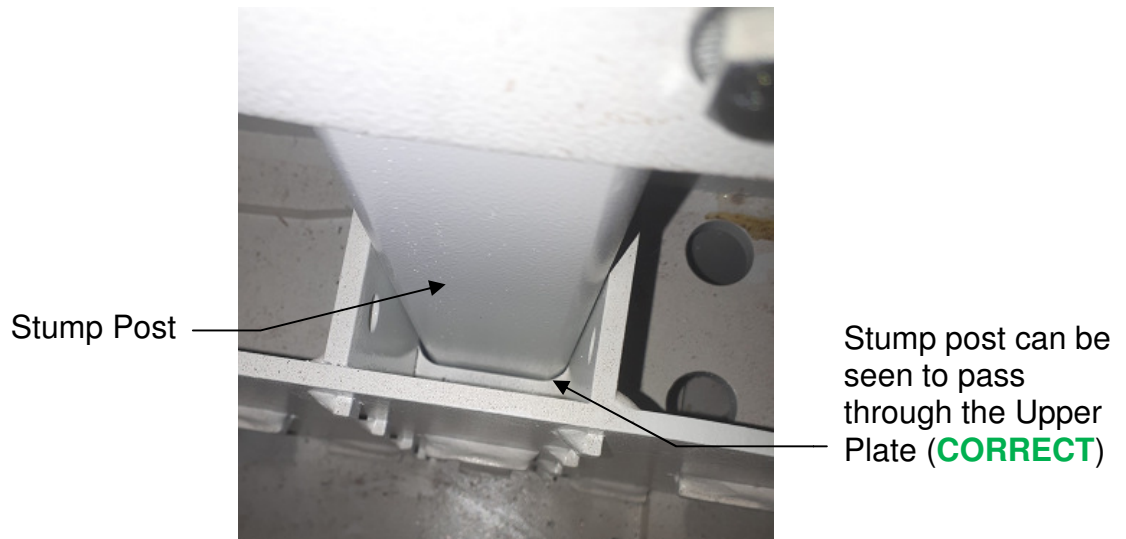
**It must be confirmed that the stump post passes through the upper plate of the stump base** (as per image overleaf).

If packers can be seen instead of the top plate then the lift must be removed from service until corrective work can be undertaken.
