TB 173

TECHNICAL BULLETIN

Product : Midilift XL+

Subject : Incorrectly wired mains supply cable

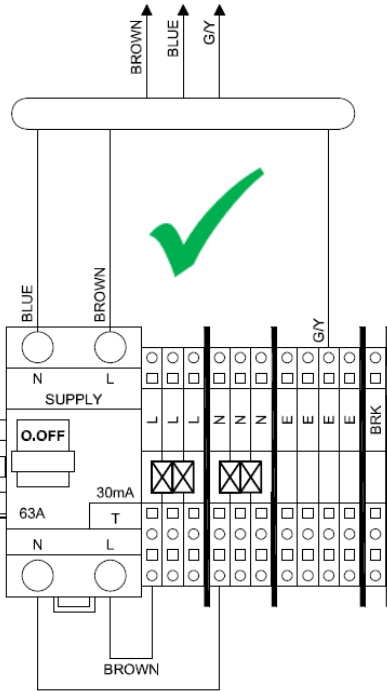
CORRECT

Lift mains supply.
Terminated in lockable isolator by builder.

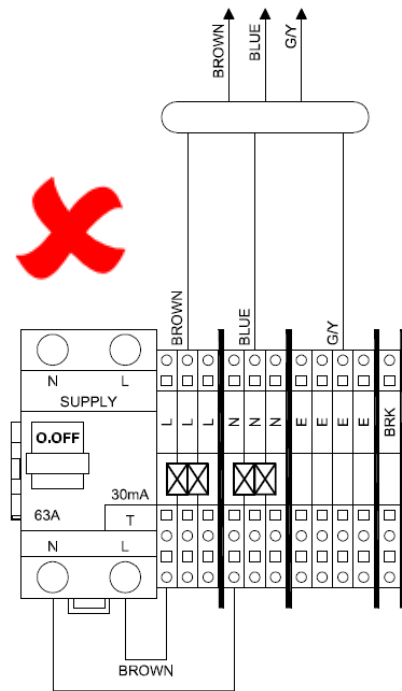
INCORRECT

On a recent XL+ installation it was identified that the 230VAC incoming lift supply had been incorrectly wired. This resulted in the lift RCD isolator, located within the upper landing control panel, being bypassed.

Lift mains supply.
Terminated in lockable isolator by builder.

1. Turn off and lock off the mains supply to the lift.
2. Confirm mains supply is isolated.
3. Reconnect the mains supply as per wiring manual drawing 9448-24.
