TB 176

TECHNICAL BULLETIN

Product: Midilift SLplus & XLplus

Subject: Mechanical safety edges – maintenance checks

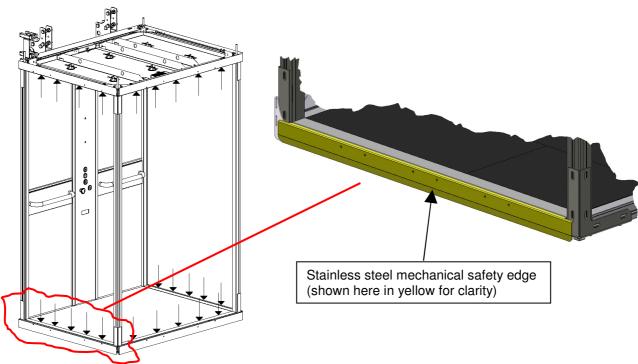
The Midilift SLplus and XLplus models are equipped with mechanical safety edges located at the floor and roof of each cabin entrance(s). These are the primary protection means when the cabin is in motion, with the light curtains providing secondary protection. It is therefore important that the mechanical safety edges are checked in accordance with the product maintenance guide.

Following an associated component failure on an SLplus, a hazard analysis has identified an improvement to the recommended servicing checks for the mechanical safety edges.

The product maintenance guides have therefore been updated to provide more detail in relation to the checking of operation and condition of the mechanical safety edges.

Engineers are reminded that the checking of these mechanical safety edges is a requirement at each 3 monthly service visit, as a minimum.

All future safety edge checks must be in accordance with the latest versions of the product maintenance guide (at time of writing, issue 3 for SLplus and issue 6 for XLplus). Latest copies are always available at www.stannahtechnical.co.uk
