TB 179

## TECHNICAL BULLETIN

**Product:** Stannah Platform Lift - Midilift XL Plus

**Subject:** Tension Pulley Device for Overspeed Governor Rope

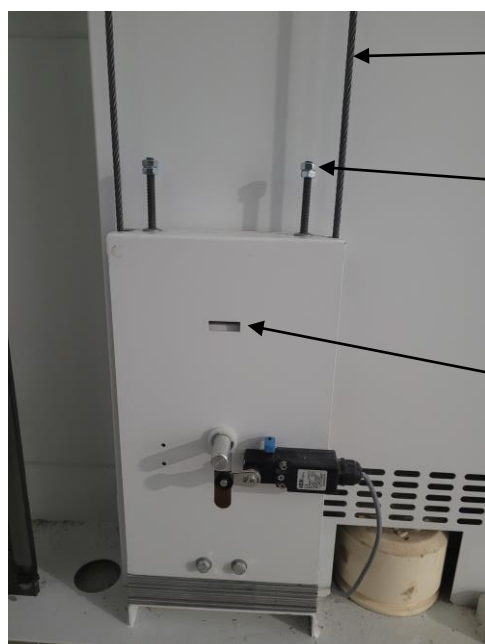
Overspeed governor rope

Ensure that the top of the pulley bracket is visible within the indicator slot. This ensures that correct tension has been applied within the governor rope.

Ensure that the M8 nuts on top of the assembly have **been loosened completely and locked off with a second nut** after the governor rope has been installed.
