**TB 190**

## **TECHNICAL BULLETIN**

| For the Attention of: | Platform Lift Installers |
|---|---|
| Product: | Stannah Midilift XL+ |
| Subject: | Control unit front panel earth tab |

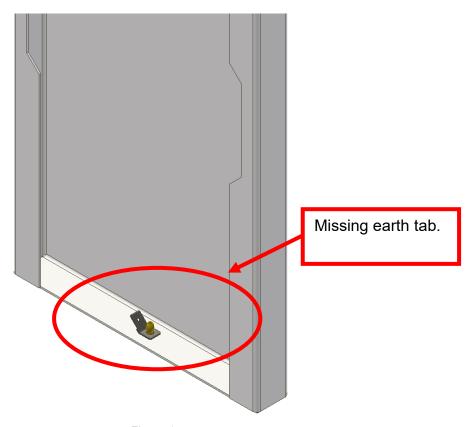
Figure 1

It has become apparent that some XL+ upper landing control unit front panels have been assembled without the earth stud (see Figure 1). If this panel remains unearthed there is an increased risk of an electric shock.

If inspection of the control panel confirms that no earth tab has been fitted an earth tab retrofit kit can be ordered through Stannah lifts spares department under part number 950531.
