TB168

SAFETY BULLETIN

Subject : Incident Report 2339 – Platform lifting mid travel
Product: Stairiser CR

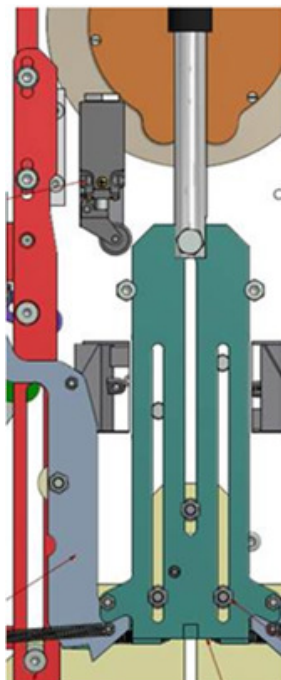
The root cause was found to be failure of the barrier arm switch S11m. The switch was replaced and no further occurrences have been reported

Should you experience a platform stopping and the platform attempting to fold away from floor level, switch S11m should be checked in the first instance. The switch should be changed and the mechanical slide readjusted as per the installation manual.
