TECHNICAL BULLETIN

Product : Stairiser SX, external model

Subject : Rusting

Originator : Stannah Lifts Ltd, Anton Mill, Andover, Hants SP10 2NX 01264 339090

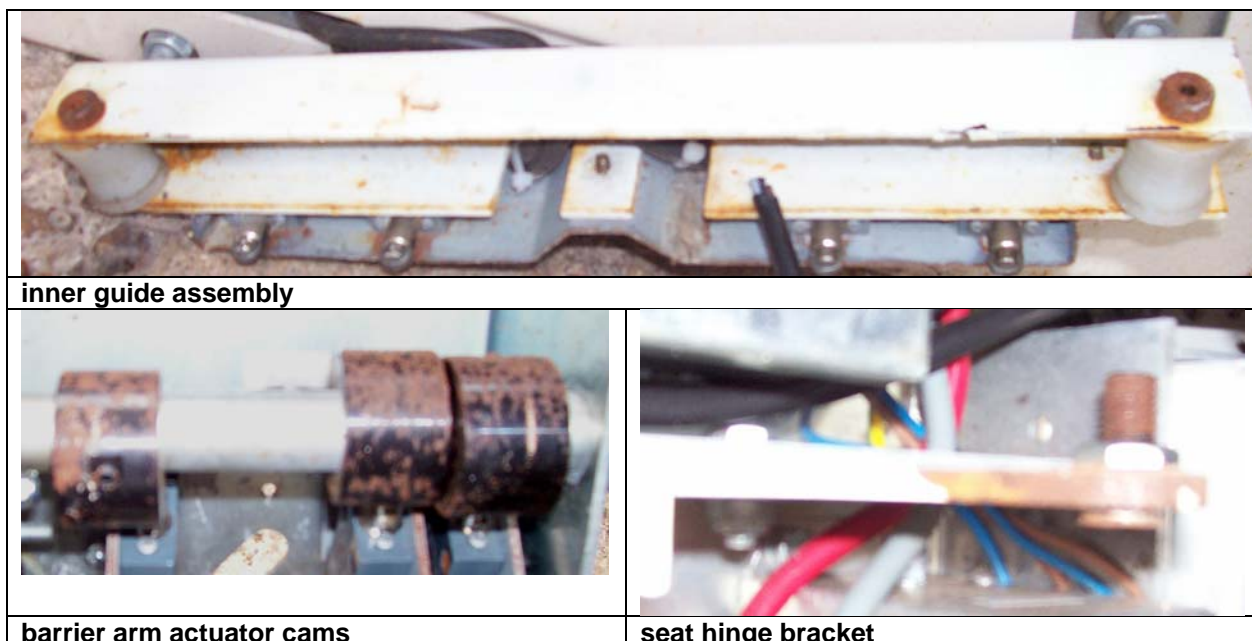
3 components located on Stairiser SX external units manufactured before July 2007, have been found to suffer rusting due to an incomplete coating process. It is considered prudent that these components should be inspected & monitored in the field during service.

It is requested that the following 3 components are inspected & monitored for signs of excessive rusting in line with normal inspection practice. If it is considered that the integrity of any component has been affected, the component shall be replaced & sent back in accordance with the component warranty returns procedure.

The service routine should include an application of light grease to the affected components.
