TB MP0025

TECHNICAL BULLETIN

From: Tony Knapp, Stannah Lifts Ltd Tester
Date : 15th January 2018
Product : Xtralift 2.0 (MP)
Subject : Safety Gear Bar
Pages : 2

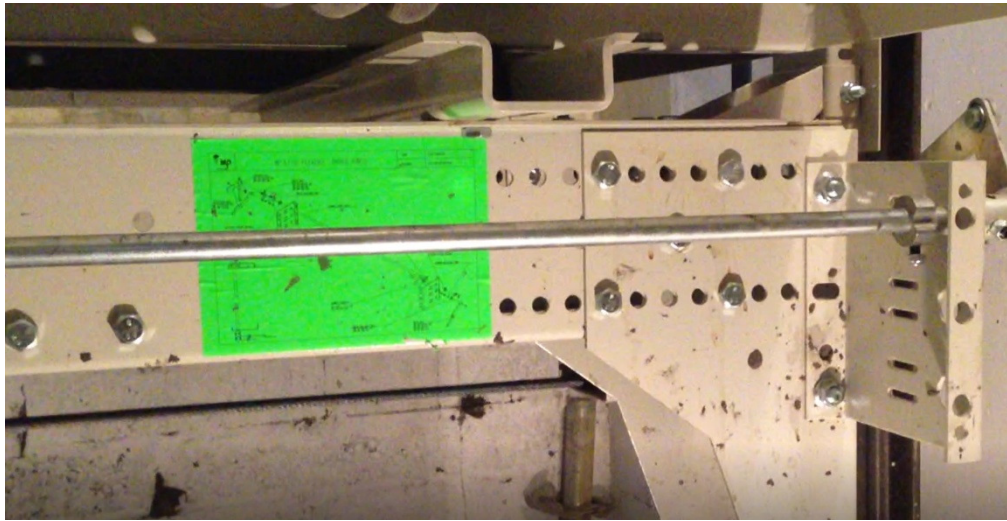
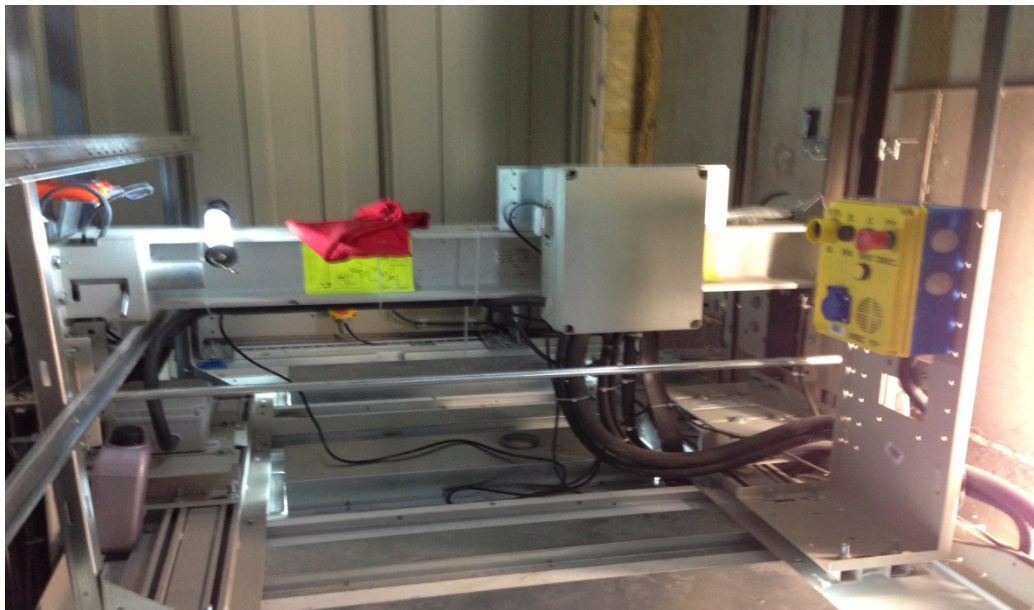
During a recent product incident, the Branch received a call to attend site after the Fire Brigade had released trapped passengers. The Engineer found that the safety gear had activated in the down direction and was stuck on the third floor. Engineer reported that there appeared to be something wrong with the safety gear but he was unsure as to what. FSM attended site and carried out an investigation. He found the safety gear linkage arm had completely come free from the safety gear. He was unable to confirm the root cause for this.

The safety gear is sent preassembled from the supplier, however, adjustments are then required to be carried on out site as per the stickers. Please ensure when working on safety gear all the nylocks are in place and tightened correctly, and photos of this would also assist.
