TB MP0026

TECHNICAL BULLETIN

Product : Xtralift 2.0 (MP)

Subject : SMQ 4 Board & Interface tool

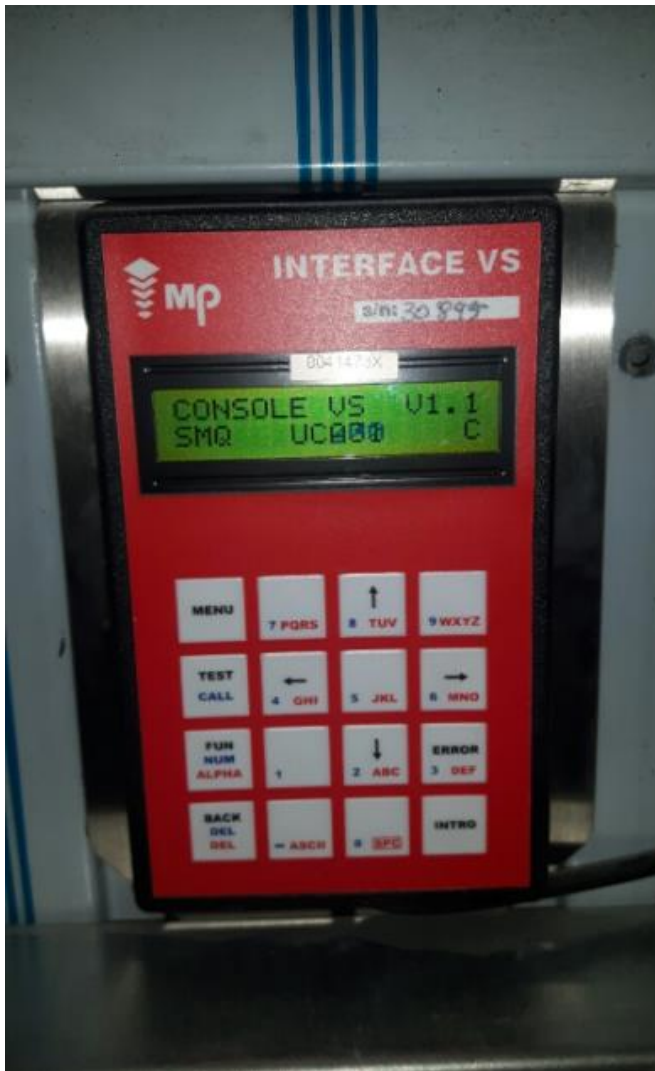
We have experienced VS controllers not re-setting after power cuts. Normally the controller would reset after a power loss but in some cases the controller gives communication errors 09 31, 09 41 and fails to reset. See MP report below:

After the automatic rescue the lifts switch off, and will be back on when the power returns, When the internal console (red Tool) is connected the controller can have a problem starting up the CAN bus and this can generate the, Fault 09-41 and 09-31.

Please can all engineers ensure they unplug the red interface tool on the lift when they leave site. This only applies to EN81-20 lifts where the red tool is mounted on the controller door not EN81-1 lifts where tool is mounted directly on top of the SMQ4 board, or where the Interface tool is hard wired into the SMQ4 board.
