LIFT TYPE:- System 21 Lifts - Ram straps.

To: Stannah Services
Trade Customers.
Installers
Testers

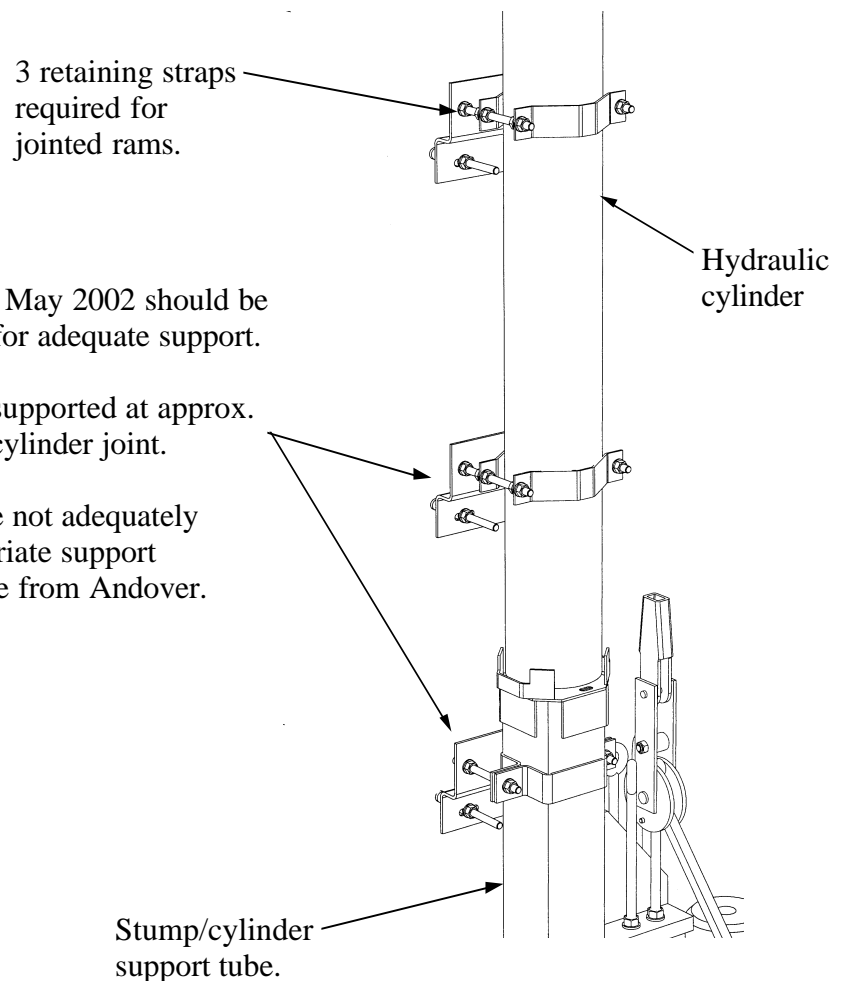
We have recently experienced a problem with the lack of support between the base of the piston and the top of the piston stump, for indirect acting lifts.

All system 21 lifts installed from May 2002 should be checked at the next service visit for adequate support.

The piston and stump should be supported at approx. 300mm either side of the stump/cylinder joint.

Any pistons or stump found to be not adequately supported are to have the appropriate support bracketry fitted which is available from Andover.
