Stannah Lifts Safety Bulletin

Issue No: M20

LIFT TYPE: - Stannah Hydraulic Passenger Lifts with 2:1 Roping

Component Failure

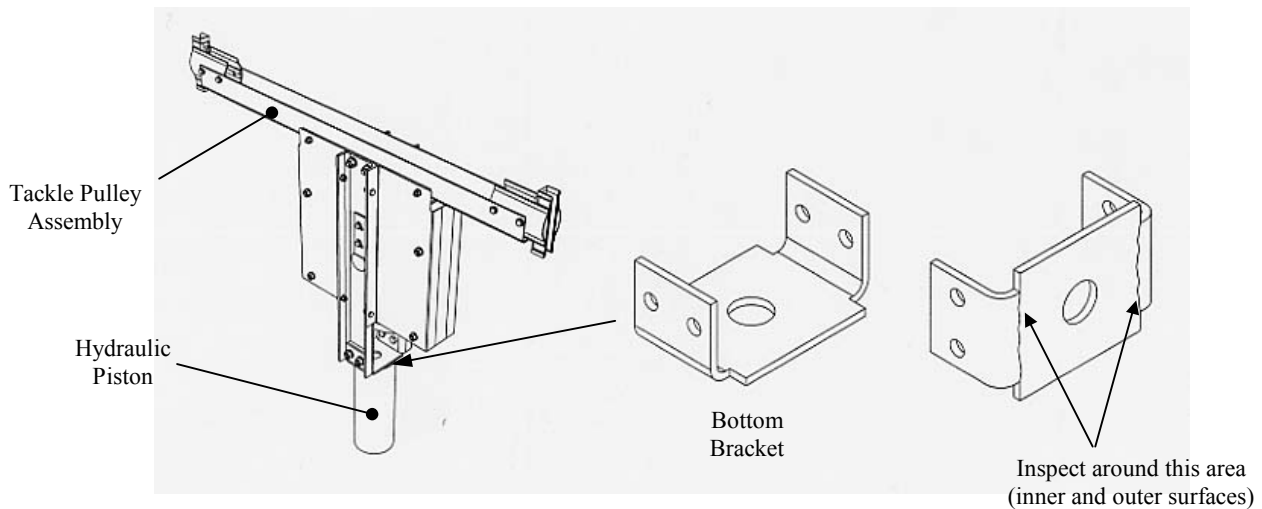
We have experienced a problem with a steel bracket on a 4 year old lift, which appears to have cracked before eventually failing. The bracket design has been in use since 1986.

The bracket is fitted at the base of the tackle pulley assembly which supports the main suspension ropes and secures the top of the piston to the tackle pulley assembly (*see picture below*).

During the next service visit, inspect the bottom bracket carefully for any signs of cracking, distortion or other imperfection on any Stannah Hydraulic Passenger Lift with 2:1 roping.
