Stannah Lifts Safety Bulletin - Update

Issue No: M20(a)

LIFT TYPE: - Stannah Hydraulic Passenger Lifts with 2:1 Roping

Component Failure

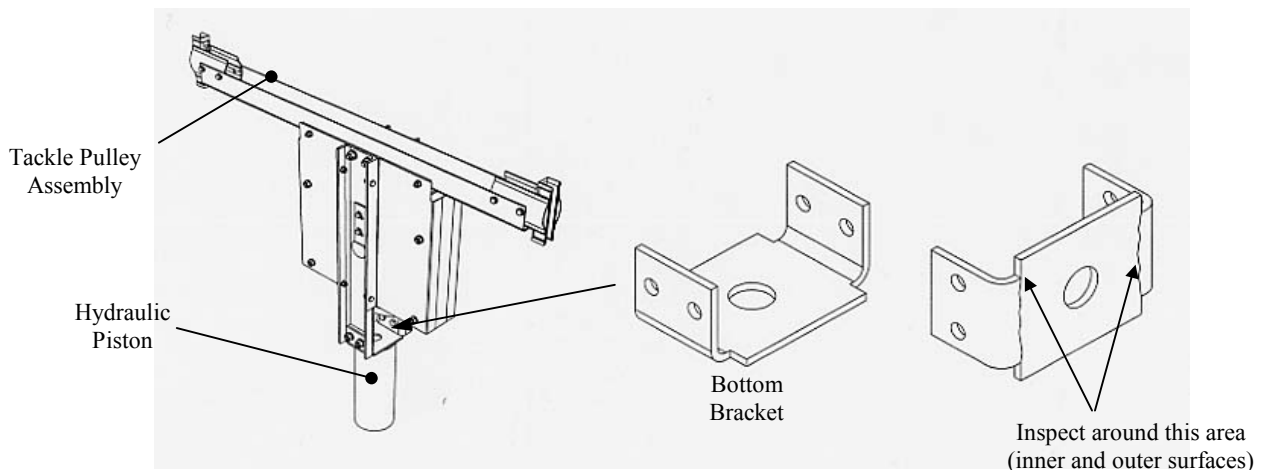
On 20/08/03 Stannah Lifts Ltd issued a Safety Bulletin, ref.no. M20, to inform that they had experienced a problem with a steel bracket on a 4 year old lift, which appeared to have cracked before eventually failing. The bracket design had been in use since 1986.

The bracket is 6mm thick and is fitted at the base of the tackle pulley assembly which supports the main suspension ropes and secures the top of the piston to the tackle pulley assembly (*see picture below*).

No further related incidents have been reported. However, as a precautionary measure, Stannah Lifts Ltd. have fabricated a clamp to strengthen the assembly. The clamp takes approximately 20 minutes to install and requires no specialist tools.

It is recommended that all tackle pulley assemblies incorporating the above bracket are fitted with this additional clamp.
