Stannah Lifts Safety Bulletin

Issue No: M31

LIFT TYPE: - Stannah Hydraulic Passenger Lifts with 2:1 Roping

Component Failure

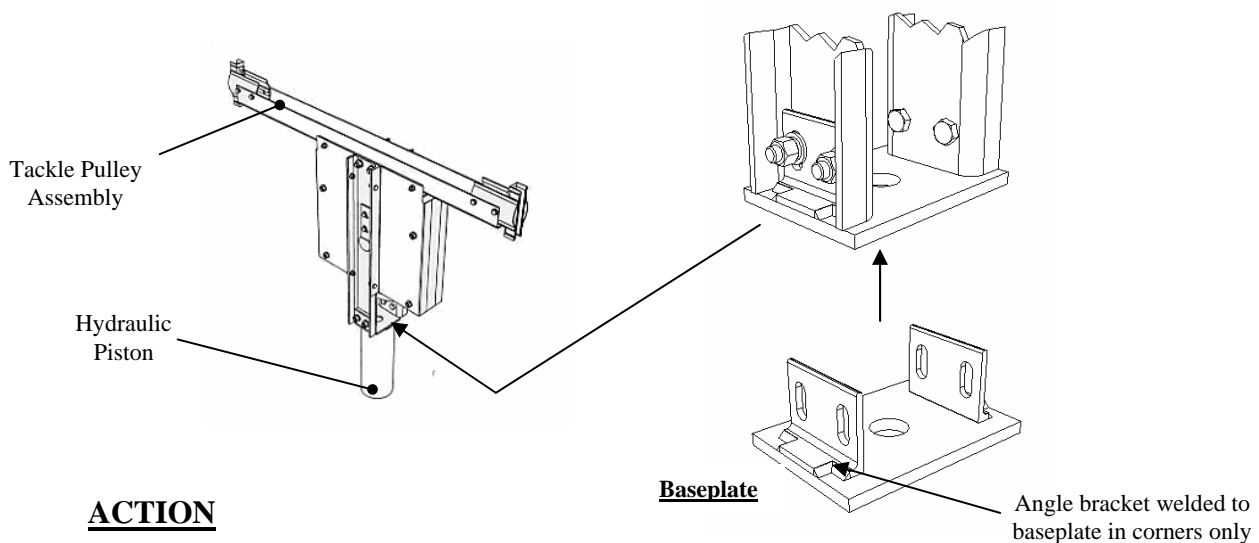
We have experienced another separate incident with a steel bracket fitted at the base of the tackle pulley assembly. The lift was installed in 1987 (ref no. J1843). This bracket is of a different design to the folded steel bracket referred to previously in Safety Bulletin M20.

The details of the baseplate are shown below. The bracket failed due to welds breaking which secure the notched angle brackets to the 10mm thick baseplate. It is currently uncertain how many brackets of this design are in the field.

- Maintenance Engineers must inspect tackle pulley baseplates during service visits and any identified as the above design are to be reported immediately to Pete Jeffery (details below).
- Any installations with a Stannah Lifts reference number between J1800 and J1900 should be inspected urgently and the details of the design sent to Pete Jeffery – any photographs would be helpful.
- LG1 safety tests are to cease on any installations with the above bracket with immediate effect and until further notice.
