Stannah Lifts Safety Bulletin - Update

Issue No: M31(a)

LIFT TYPE: - Stannah Hydraulic Passenger Lifts with 2:1 Roping

Component Failure

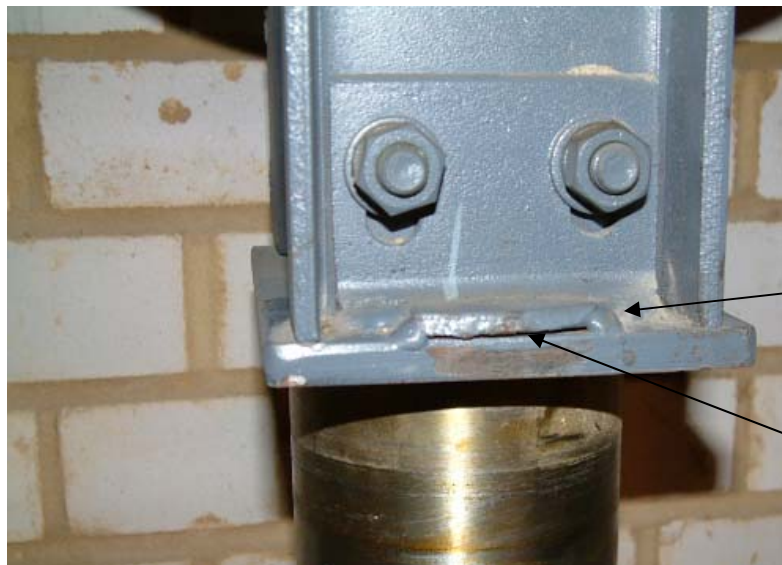
On 12/12/05 Stannah Lifts Ltd issued a Safety Bulletin, ref.no. M31, to inform that they had experienced a problem with a welded steel bracket on an 18 year old lift, which failed due to welds breaking.

The welded bracket is fitted at the base of the tackle pulley assembly which supports the main suspension ropes and secures the top of the piston to the tackle pulley assembly (*see Fig 1 below*). It consists of a 10mm thick flat baseplate, to which are welded two notched angle brackets (approx 6mm thick).

Investigations indicate that this design of bracket was supplied and installed on lifts between 1986 and 1991. Evidence also suggests that the bracket which led to the incident was only partially welded and should have been fully welded as shown in Fig 2.

Only 3 other brackets of identical design/manufacture to Fig 1 (partially welded) have been identified to date in the field. None of these showed any visible signs of potential weld failure but have been replaced as a precautionary measure.

Replacement required

Welded in notched
corners of angle
bracket only

No weld along this
edge

No further related incidents have been reported. However, as a precautionary measure, it is recommended that all tackle pulley assemblies incorporating brackets identical to that shown in Fig 1 above are replaced with a different design available from Stannah Lifts Ltd.

It is strongly recommended that no full load rupture valve tests be undertaken (as required on LG1 test) on any brackets found to be to Fig 1 above.

Any replacement brackets for Fig 1 will be supplied free of charge and will be accompanied with a Sequence of Work for installation.

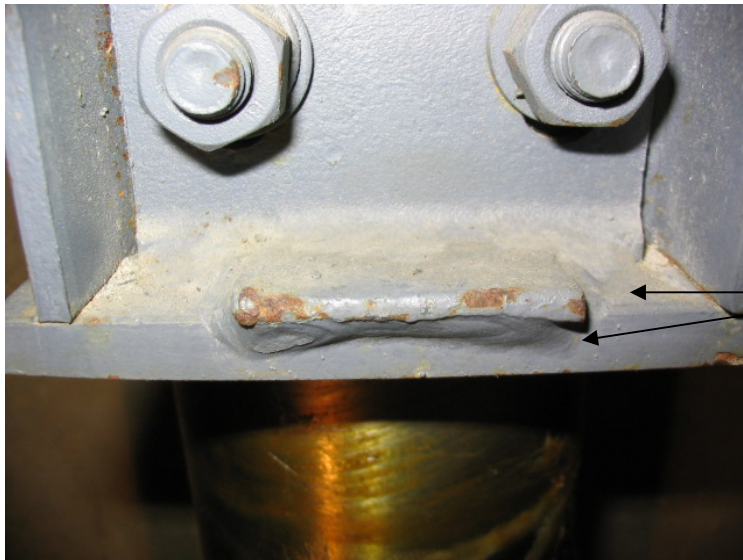
Fig 2
Replacement not required

Bracket as Fig 1
but fully welded -
in notched corners
+ along edge of
bracket.

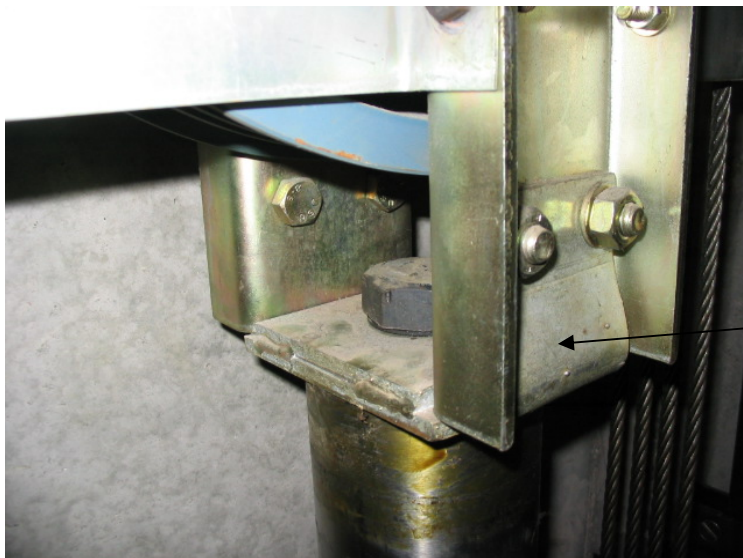
Fig 3
Replacement not required

Folded profile with
plate welded
inside.

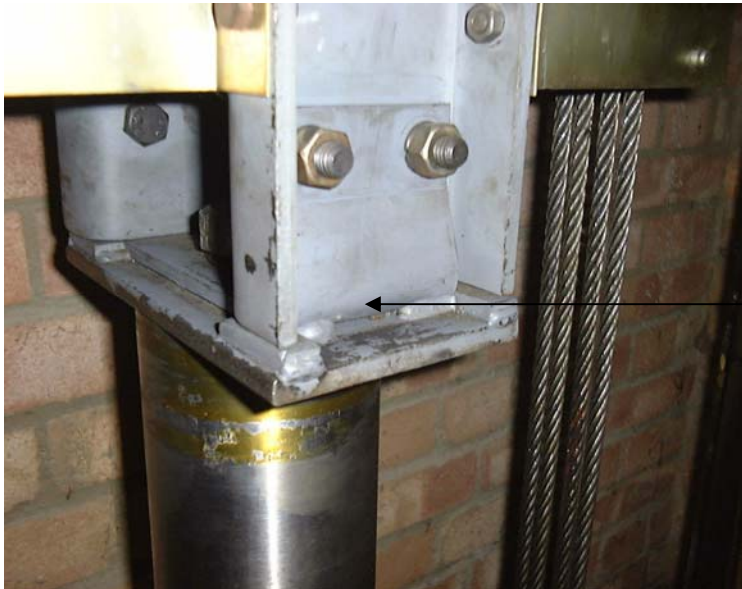
Fig 4
Replacement not required

Bracket as Fig 3 but with plate welded underneath incorporating 4 corner spacers
