TECHNICAL BULLETIN

Product : System 21 Hydraulic MRL product

Subject : Identified GEV faults

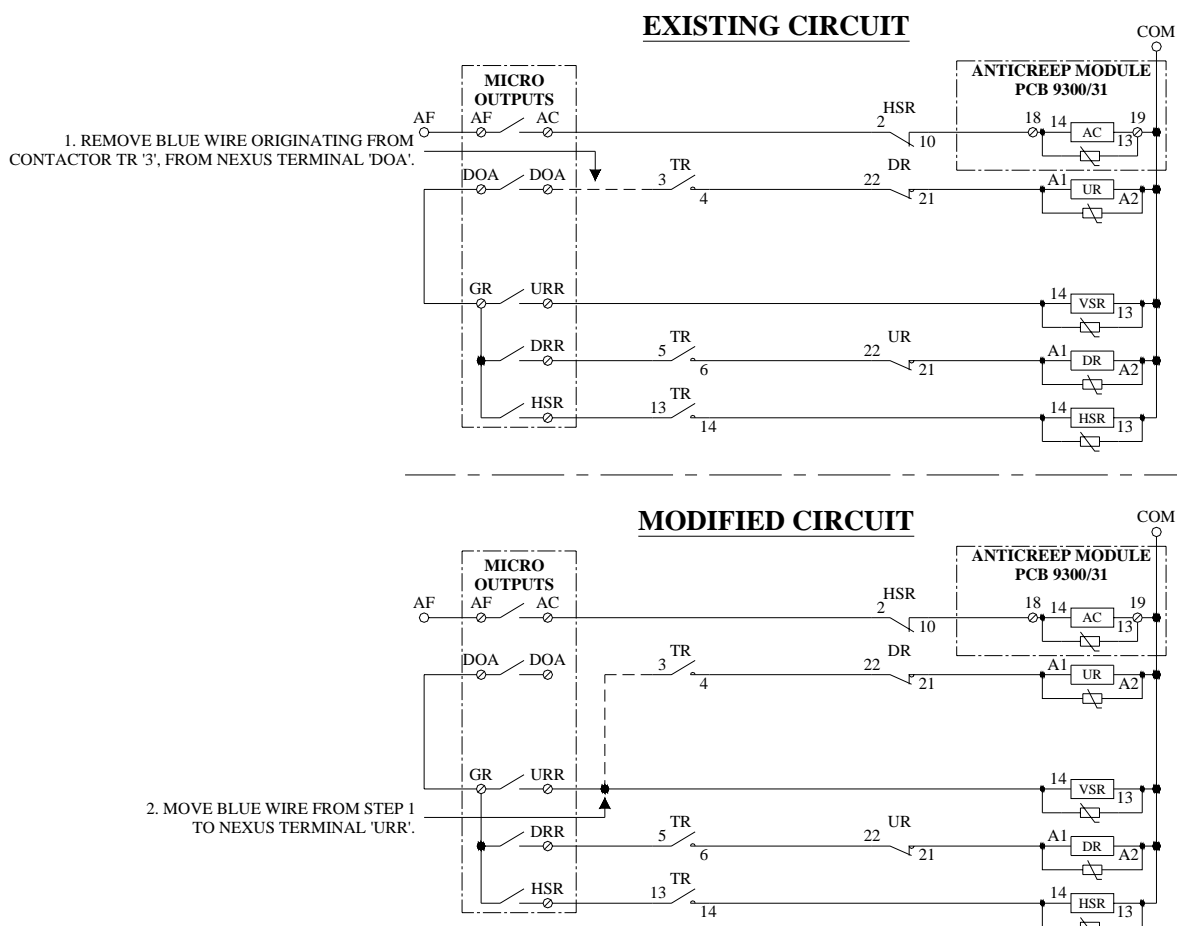
Fault A wiring modification diagram ;

Fault	Symptoms	Fix
A	Lift fails to maintain a low speed whilst levelling or releveling in the up direction. As the lift comes into floor level, it speeds up and then 'overshoots' the floor.	<ul style="list-style-type: none"> • Erratic occurrence of poor levelling • ULR faults recorded at the top floor • SCF faults with the lift found on the buffers (low pressure recorded) 	<ul style="list-style-type: none"> • On the Nexus controller, move the wire from the DOA output to the URR output (see page 2). This may result in the lift stopping short of FFL in the up direction. The 'up stopping' vane may have to be moved to compensate.
B	Whilst travelling between floors, lift speed is erratic	<ul style="list-style-type: none"> • Customer complaints of lift starting and stopping or 'falling' sensation. • Poor ride quality • Lift tries to accelerate from floor but doesn't move. 	<ul style="list-style-type: none"> • Likely to be a problem with the Proportional valve PV. • PV should be cleaned or replaced.

We are currently in consultation with the supplier of our electronic valve block to improve the quality of this product. Of the above fixes, problem 'A' is to be treated as a temporary solution to overcome immediate customer frustrations. Because of this, we ask that when this modification is carried out on site it is recorded and fed back, via phone or email to Richard Baugh at Stannah Lifts Ltd 01264 339090.
