TECHNICAL BULLETIN

Product : System 21 – Nexus Controller CPU PCB

Subject : Nexus 'Lock-Up' and Random Reset Faults

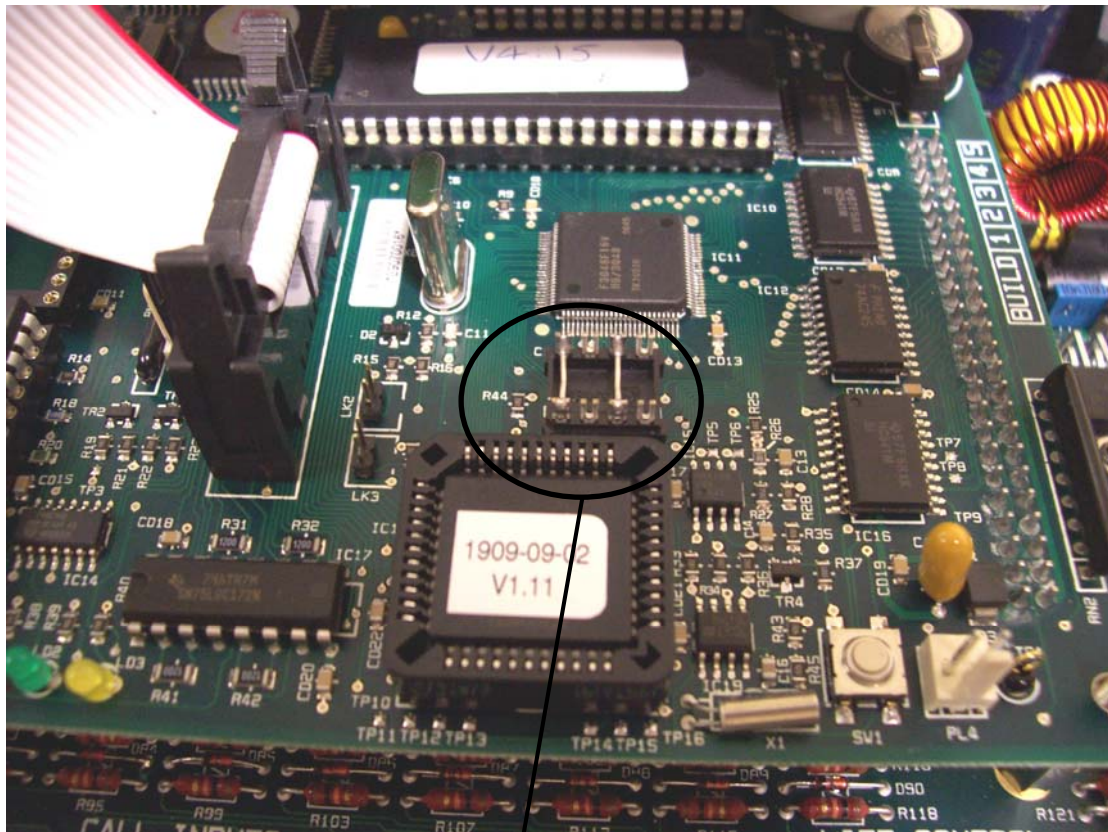
An investigation determined that the cause of the fault was a defective solder joint on the 8 pin header 'LK4', located on the Nexus CPU PCB (9300/10).

The location of 'LK4' and an example of the defective solder joint can be found on Page 2.

There may be further Nexus CPU PCBs in storage/the field that also have this fault, if one or both of these symptoms are experienced then the complete Nexus should be replaced.

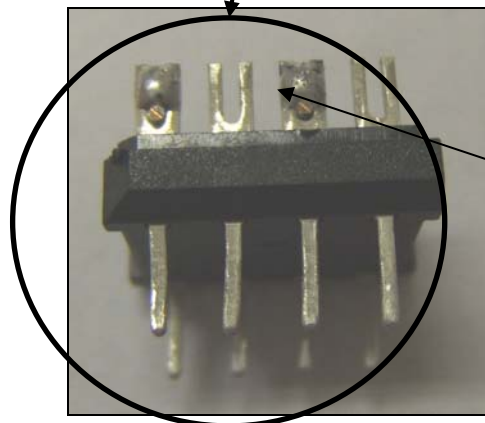
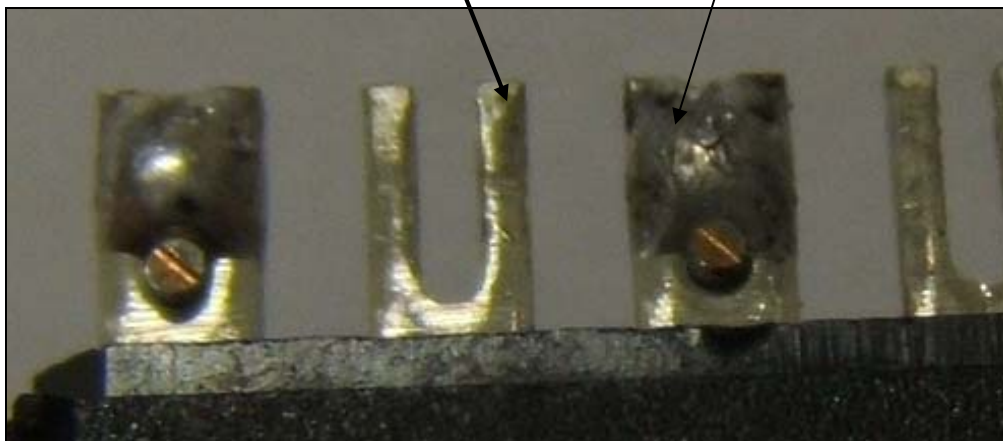
The fact that the Nexus would sometimes work may be due to the temperature of the unit. Dry joints on a PCB will often work until it warms up and expansion forces the dry joints to go open circuit or high resistance and cause the circuit to malfunction.

Dry solder joints

A manufacturing quality issue has been discovered that can result in the Nexus freezing / locking-up (allowing no further operation) or resetting of its own accord. If a Nexus is found with this fault then it should be replaced with a new unit.
