Stannah Lifts Technical Bulletin

Issue No:E 11

System 21 lifts. Manufactured prior to 1995.

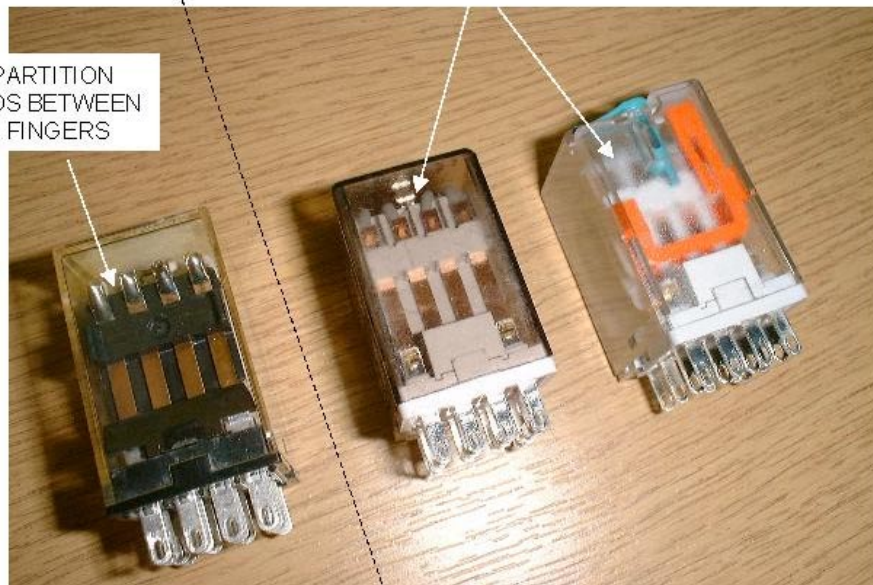
We have recently experienced a fault that occurred on a 12 year old traction lift, fitted with a Generation 1 controller. The ACR relay was found to have a short circuit within the relay connecting pins 9 and 10. The effect of the fault caused the gate lock circuit to be bypassed and created the possibility for the lift to travel with the doors open under certain test control conditions.

ARC SHIELDS FITTED

NO PARTITION
SHIELDS BETWEEN
THE FINGERS

OLDER STYLE RELAY

NEWER TYPE OF
RELAY

Through investigation and risk assessment we have identified that this fault has occurred on a very early version of IMO relay that may be found on lifts manufactured before 1995 (this is identified within the door of the control cabinet). The later versions, supplied by IMO, include additional arcing shields at the top of the 'fingers' that reduce the risk of this fault ever occurring. Therefore we request that at the next available service visit, any lift, hydraulic or traction that still contain an ACR relay of the 'older style' should be replaced with a newer version of relay. Please see attached diagram for further information on identification of relay.
