GEV FAULT FINDING GUIDE & SERVICING NOTES

This document provides a logical sequence to resolve performance problems, which may arise on the GMV GEV electronic valve system, used on the Stannah MRLi product.

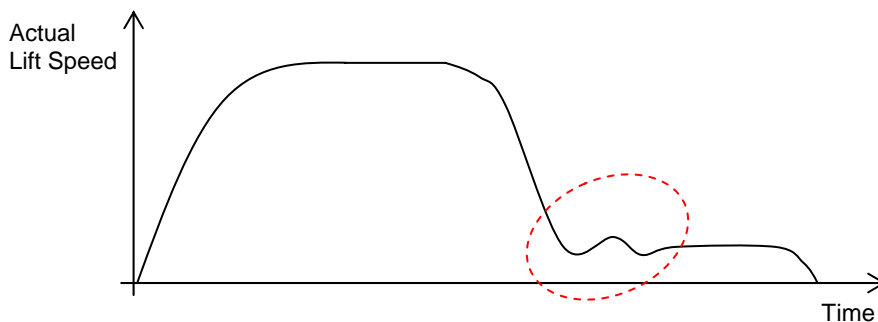
Sometimes “bouncing” may be observed at the end of the deceleration phase of a journey. This symptom is usually only found on longer travel lifts and can be observed using the GEV-DS logging software.

A graph similar to that shown below will be observed:

This effect can be eliminated by selecting the “Custom” setting for the deceleration (5-7 for up, 6-7 for down). The Custom value is then adjusted in the advanced parameters (menu 9 on the hand held programmer).

The custom up deceleration is adjusted by changing parameter 135 (negative number), the custom down deceleration is adjusted with parameter 145 (positive number). The value is in mm/s^2 .

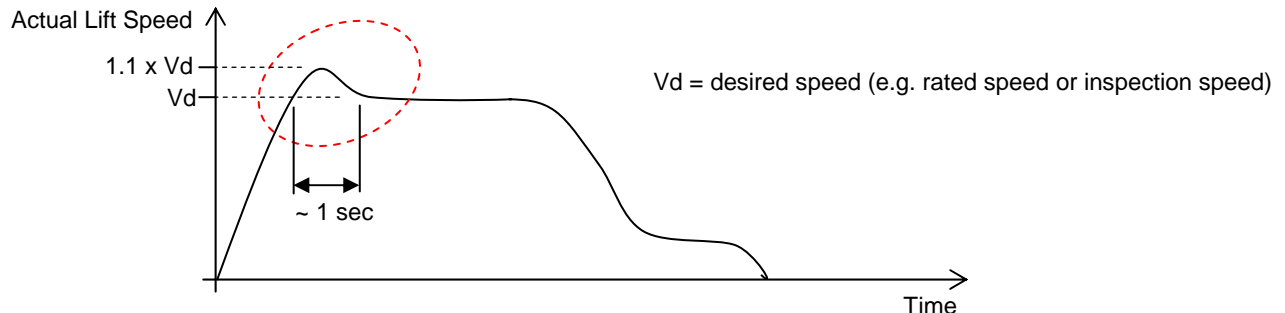
If the lift overspeeds at the end of the down acceleration phase and then later stabilises at the desired speed (rated speed, intermediate speed or inspection speed) the down acceleration gains may need to be adjusted in the Advanced parameters.

Parameter 193 (P gain) has a maximum value of 18,000 and can be adjusted in increments of 1000.

Parameter 194 (I gain) has a minimum value of 100 and can be adjusted in increments of 50.

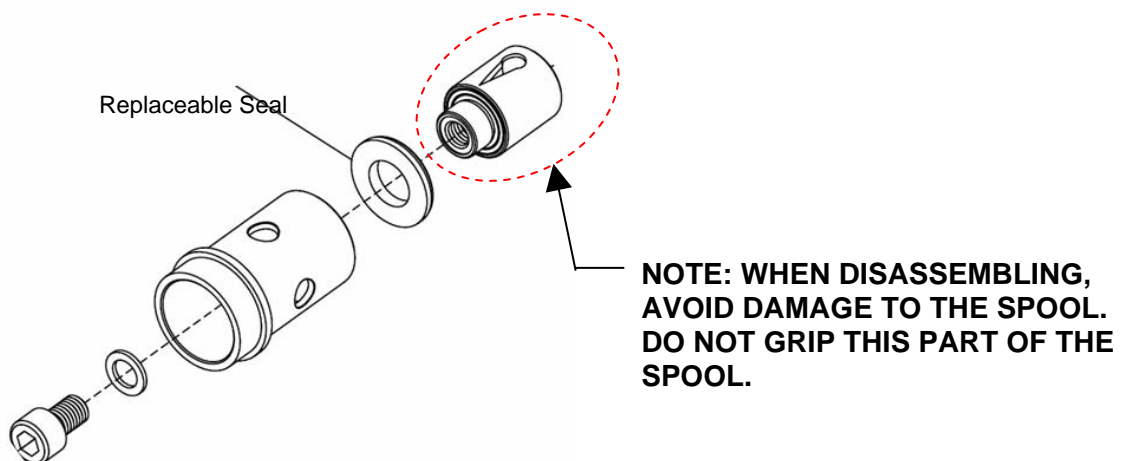
2(c) Main non-return valve (VRP)

- The VRP spool incorporates a replaceable seal (see below)

- Remove the cap head screw. To prevent damage, care should be exercised when gripping the spool (see diagram above).
- Separate the two halves of the spool
- Replace the seal
- Re-assemble VRP and tighten the cap head screw

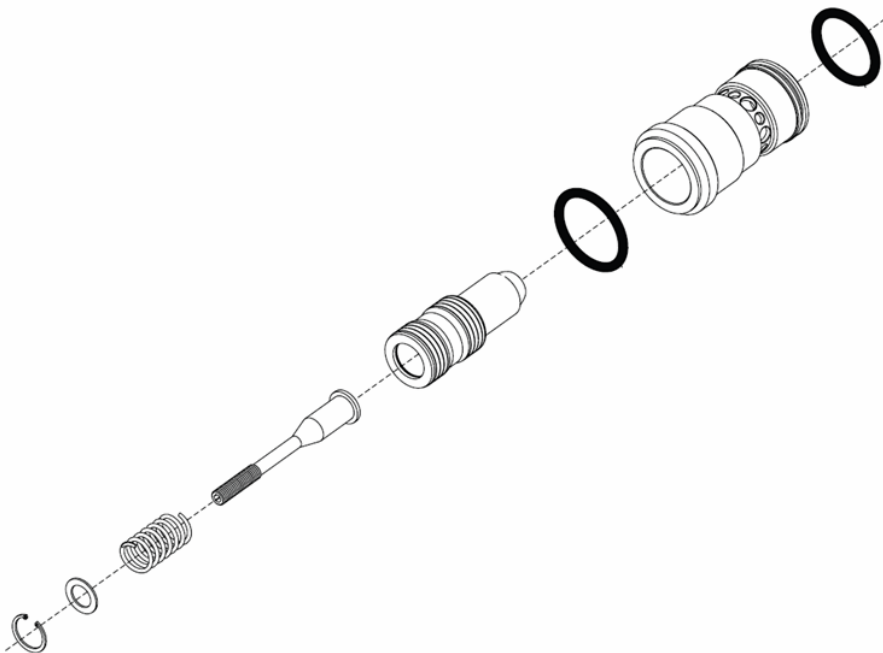
3. VB Spool

- The most likely cause of a problem with the VB spool is that it doesn't move freely and/or it sticks at the fully closed position after a down journey has been completed (since VB is driven fully closed by the current applied to PV).

- Remove the VB spool and sleeve.
- Check the spool moves freely.
- Move the spool rapidly towards the closed position. After this the spool should be able to be pulled open easily - if it sticks in the closed position the sleeve and spool must be replaced. Note: To change the VB spool and sleeve on the MRL tank, it is necessary to move the valve block across (as there is insufficient space between the valve block and the side of the tank).

- After re-installing the VB spool and liner, the bypass pressure needs to be reset. Note: If problems are experienced when setting the bypass pressure, screw 8 should be wound out fully and then wound in to achieve the 6 to 7 bar setting.

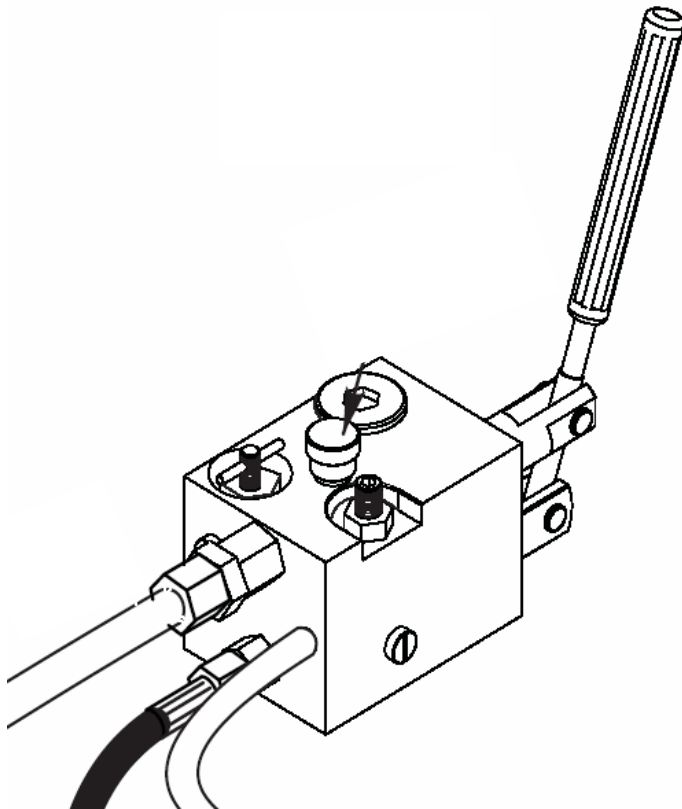
5. Remote Hand Pump

If air re-enters the suction pipe after the system has been bled, check the following:

- Ensure the locknut on the pressure relief valve is done up tight
- Check that all pipe connections are tight. PTFE tape can be used on the low pressure hoses to reduce the possibility of air entering the system.
- If a fitting with a copper washer is removed from the hand pump, the copper washer should be replaced with a new one (as the sealing face may have indentations in it causing a leak).
- The remote hand pump pressure relief valve should not be adjusted too low (should be 2.3 x max static pressure).

Note: The pressure relief should be adjusted at the remote hand pump, NOT the hand pump on the GEV valve block
