TB KLM009

TECHNICAL BULLETIN

For the Att	ention of :	Branch Managers, SLL Contract Managers, SLL Testers, SLL Installers, SLL Installations Manager
Date : Product : Subject : Pages :	16 January 2017 Kleemann Flexy – aka Stannah Maxilift 2.0 Controller Socket 3 pages	
Originator :	Stannah	Lifts Ltd, Anton Mill, Andover, Hants SP10 2NX 01264 339090

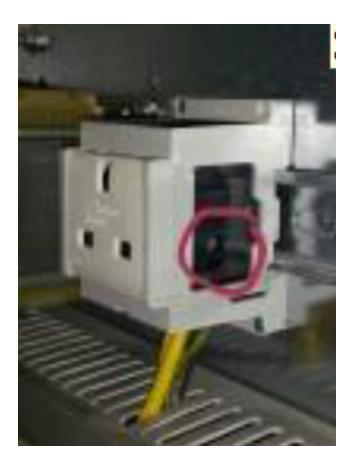
Picture no 1

Back in 2016, a service engineer attended site and found the Kleemann controller socket had no sides, top, or bottom cover, so potentially you could get an electric shock from the terminals or bare wires. See picture no 1:

Upon investigation it seems Kleemann locate the socket in the controllers in many different places. The socket is protected by an MCB that is also protected by an RCD.

- Only competent persons who are authorised should access a lift control cabinet;
- Please follow established work methods when working within a control cabinet;
- If you see a socket that you believe to be a risk, then please relocate and or order a replacement;
- We should start to see production models coming through with the socket sandwiched;

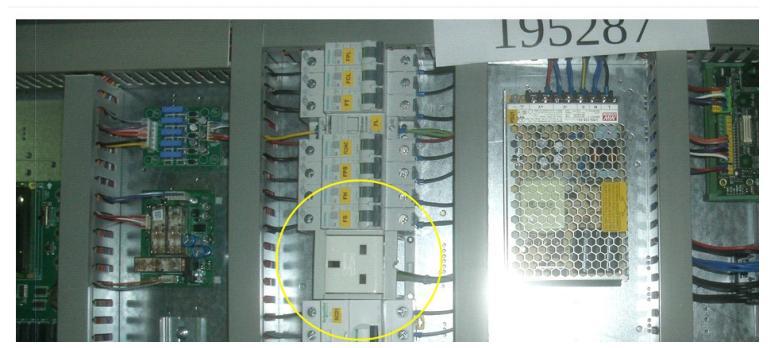
Picture no 2

Kleemann provided their Technical Memo in support of their socket / equipment, however, they have advised that they will change their production processes so that the socket is 'sandwiched' between devices within the controller. See picture no 2:

From 14 July 2016 production will relocate the socket to reduce the risk but we would still like to highlight there are other terminals like this in any lift controller.
