TB-MP003

## TECHNICAL BULLETIN

**From:** Peter Canning – Passenger Lift Tester, Stannah Lifts Ltd  
**Date :** 11 March 2014  
**Product :** MP– MPGo model – MRL Traction  
**Subject :** **MP Inverter settings and sensitivity**  
**Pages :** 4

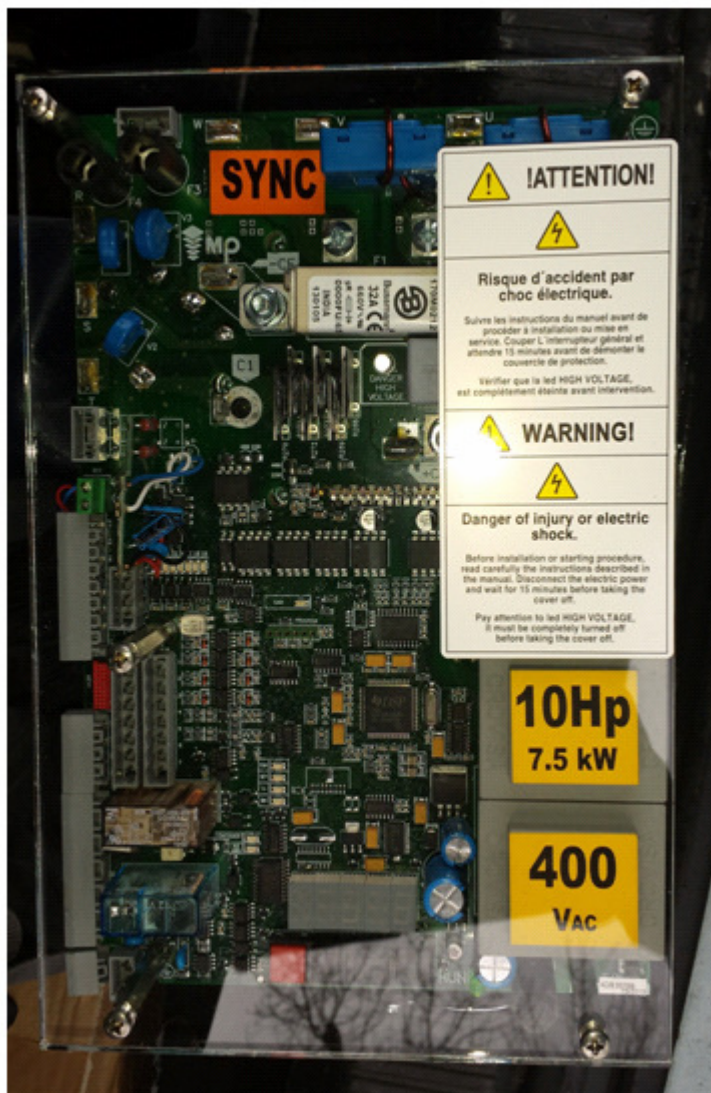
**Picture 1** - MP inverter located at the bottom of the architrave controller

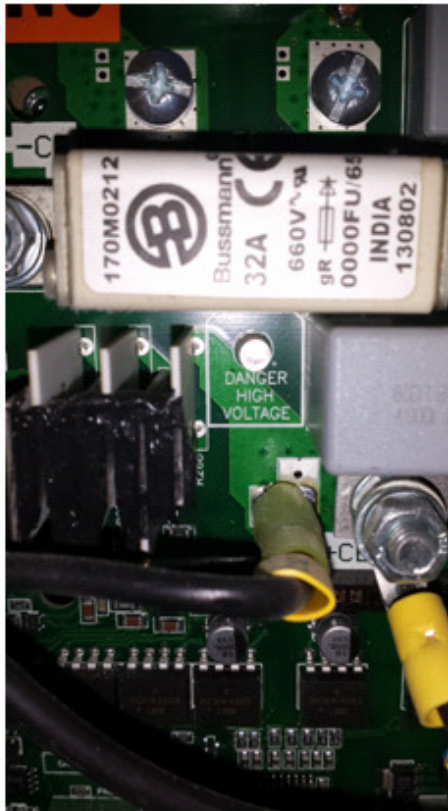
Picture 2 –  
DANGER LED off = safe to work on.

- Allow the capacitors to discharge before working on the inverter or working on anything that is connected to the inverter.
- The MP inverter is fitted with a DANGER LED for warning that the capacitors are still charge (**pictures 2 & 3**)
- Ensure that the B1, B2 and earth wires from the brake resistor are connected to the correct terminals (**picture 4**)
- Check motor connections and brake resistor connections before applying power (**picture 5**)

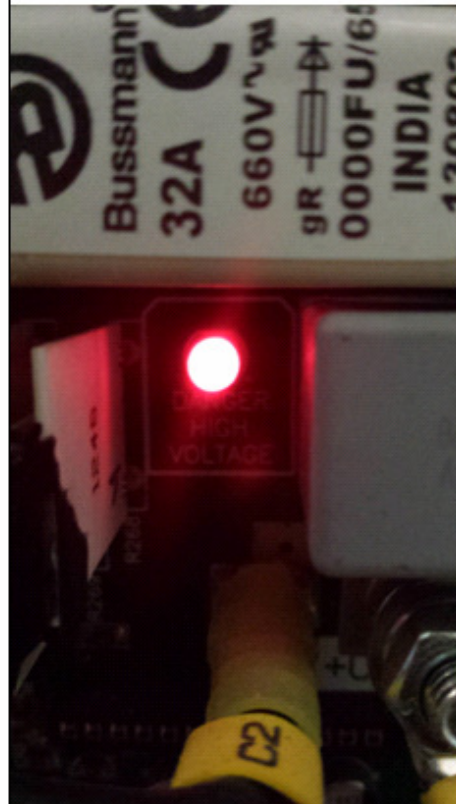
Picture 3  
DANGER LED ON (GLOWING RED)  
DO NOT TOUCH UNTIL LED IS OFF

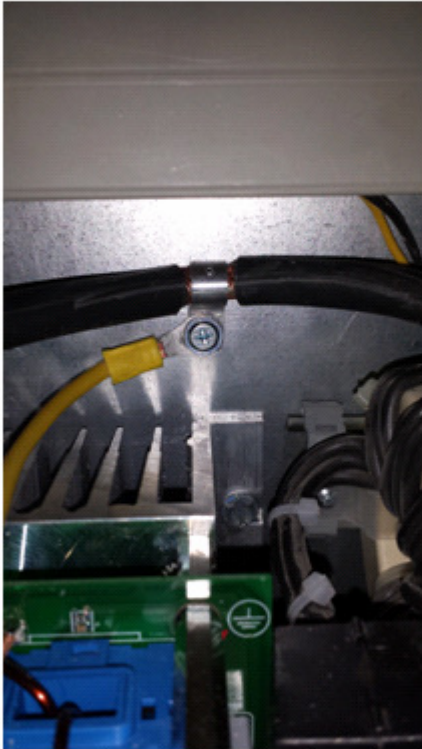
## Pictures 4 & 5

Correct earth termination for  
brake resistor

Ensure that the B1, B2 and earth wires from the brake resistor are connected to the correct terminals.

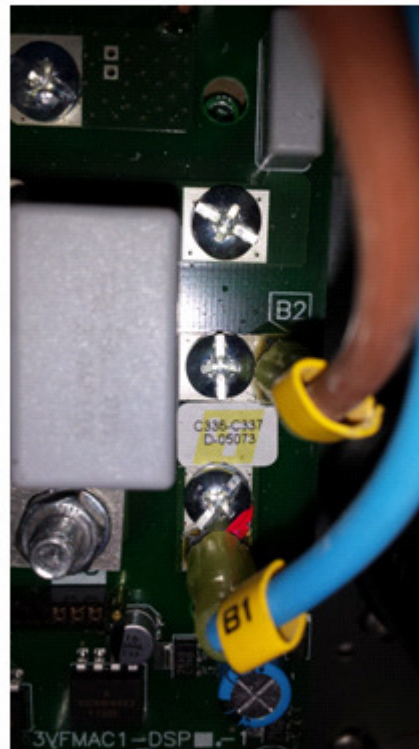
Correct termination for the brake  
resistor cables on the inverter.
