TB 175

TECHNICAL BULLETIN

Product: FX Steel structure – used on Midilift Piccolo and Passenger Lift models

Subject: Integrity of 'T' clips to secure the steel ring assemblies on FX structures.

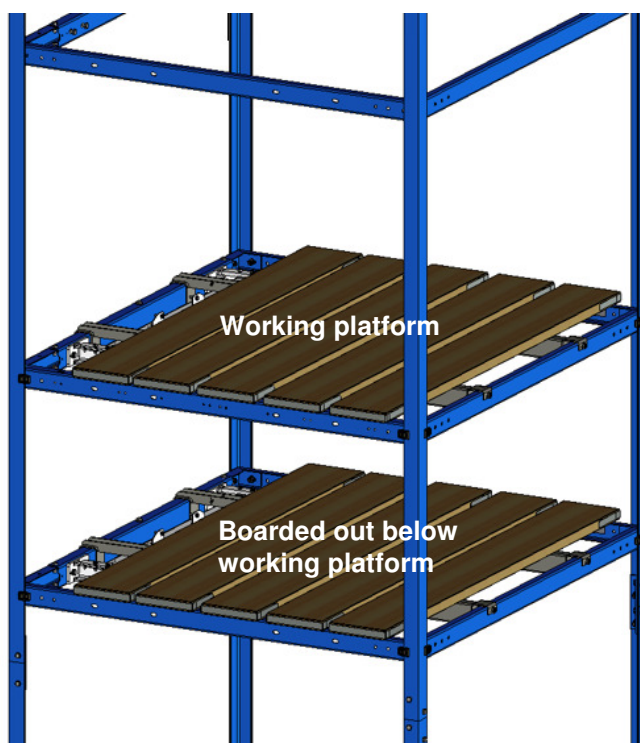
Figure 1

A near miss incident (ref 21770) has been reported on a recent Midilift Piccolo installation incorporating the FX steel structure. During the initial stage of installing the structure, one of the lower ring assemblies slipped downwards after being clamped in position using the 'T' clips. The ring assembly was boarded out and was being used by one of the installers as a working platform to build the steel structure as detailed in the

Corner angular upright

Ring assembly - clamped to angular uprights by a total of 8 'T' clips (2 in each corner)

Ring corner joint assembly

Installation Engineers: Particular care must be taken when assembling the ring corner joints on all FX structures, prior to using a boarded ring assembly as a working platform.

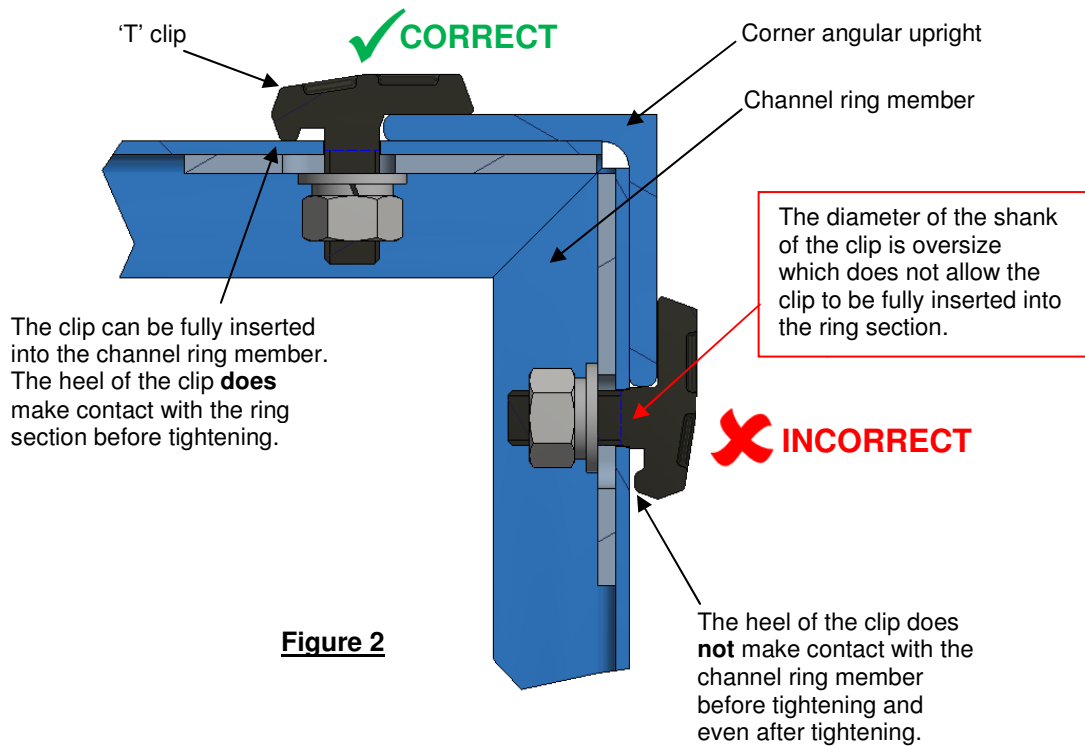
Investigations have established that the root cause was due to some of the 'T' clips, which clamp the ring assembly to the corner angular uprights, not engaging correctly (See Fig 2).

If any 'T' clips cannot be fully inserted as shown in Figure 2 then they should not be used to assemble the ring members and must be replaced with a clip that does. This is vital to ensure that the ring assembly cannot slip downwards when using it as a working platform.

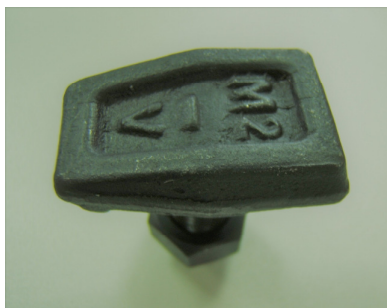
An inspection of the batch of 'T' clips at our works has confirmed an inconsistency of the shank diameter. This can result in some of the clips not being able to be fully inserted into the hole in the channel ring member and therefore not clamping with enough force when tightened to the recommended torque. The batch of clamps affected are stamped M2 as shown in Figure 3.

All lifts in storage incorporating an FX structure will be inspected and clips stamped as shown in Figure 3 will be replaced with a correct alternative batch.
